## **ANNEXE C – SURFACE WATER DRAINAGE SURVEY APRIL TO JUNE 2020**

**(with amendments and additions to February 2021)**

Carried out by  
Andrew Scarth CEng FICE

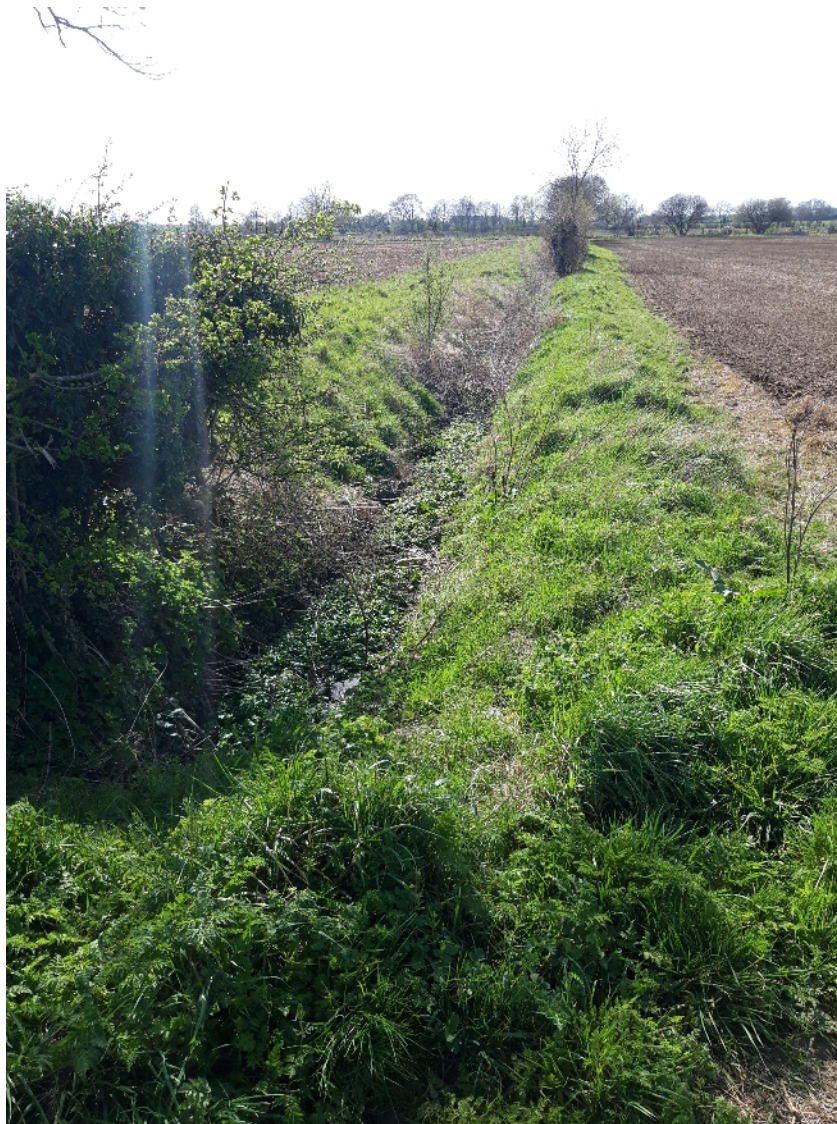
Photograph 1 - Drain A

Photograph 1 shows Drain A from the pipe under Charlham Lane track looking west. Some overgrown vegetation is evident.

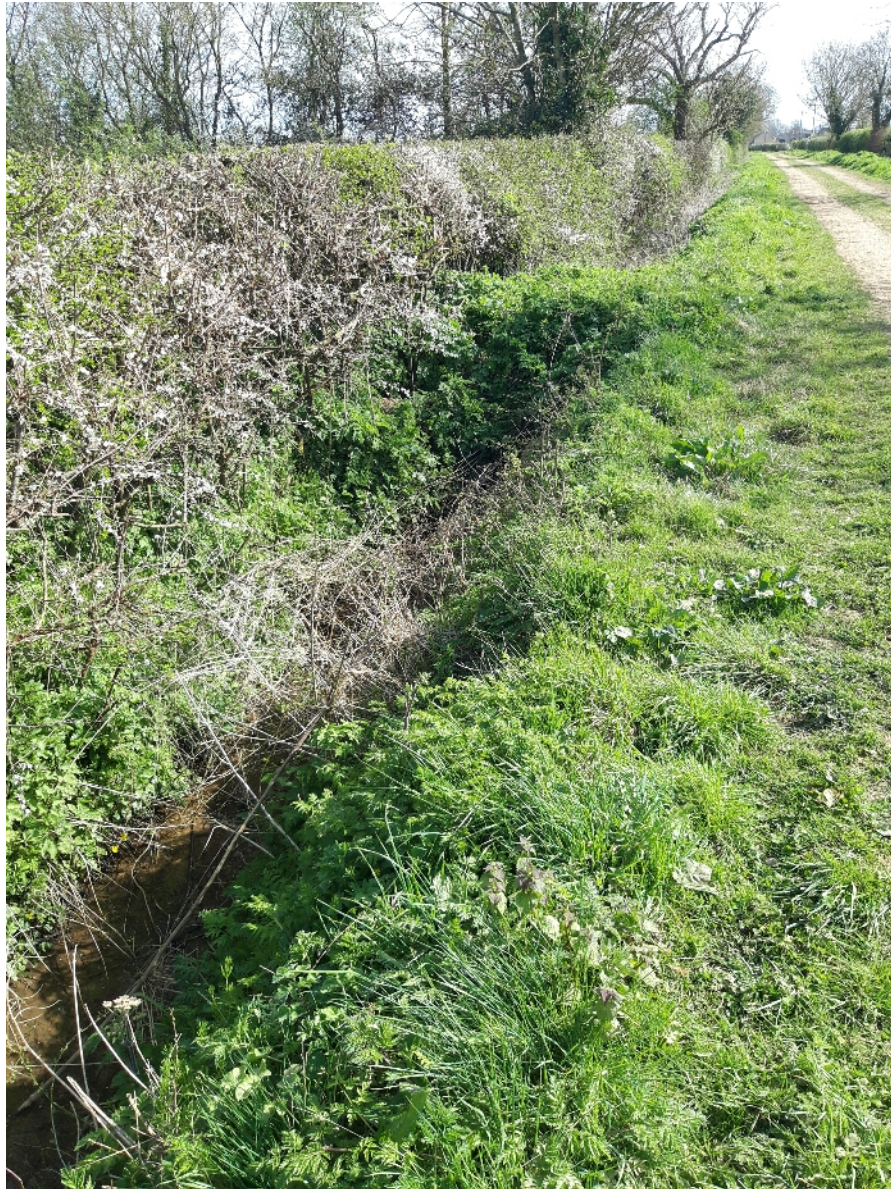
At the time of writing the Drain B1 is blocked between its junction with Drain C and its junction with Drain A. The drain and the obstruction can be seen in Photograph 2.

Photograph 2 – Drain B1 looking south showing obstruction

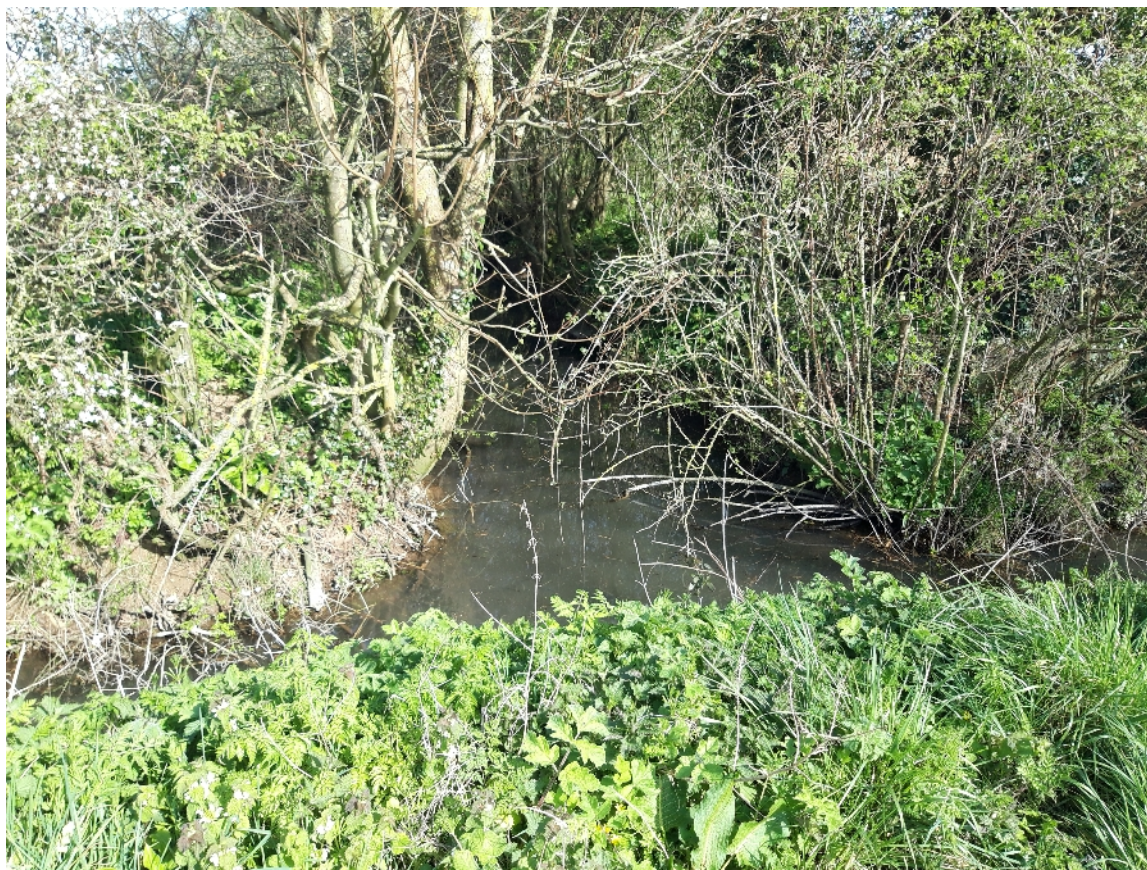
The junction with Drain C is shown in photograph 3. It is noticeable that even after a stretch of dry weather water is flowing from Drain C. This is noted later in the next section.

Photograph 3 – Drain C and Drain B1 junction

The water flowing at the junction between Drains C and B1 mentioned in the last section is coming from the pipe from Linden Lea. Water could be seen flowing from it. This part of the drain is very overgrown.

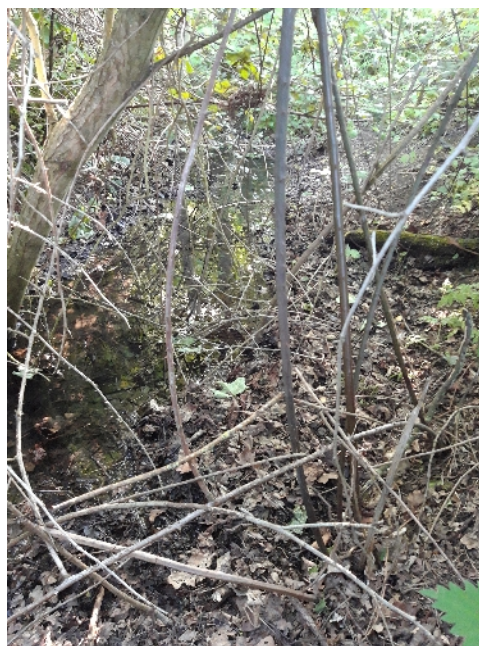
Drain C runs northwards from the end of Suffolk Place, picking up the 1050 mm pipe from Linden Lea before turning at a right angle to join Drain B1. Photograph 4 is taken at the bend

Drain C runs through a heavily wooded corridor which can be seen in Photographs 4 and 6.

Photograph 4 – Drain C at the right angle bend

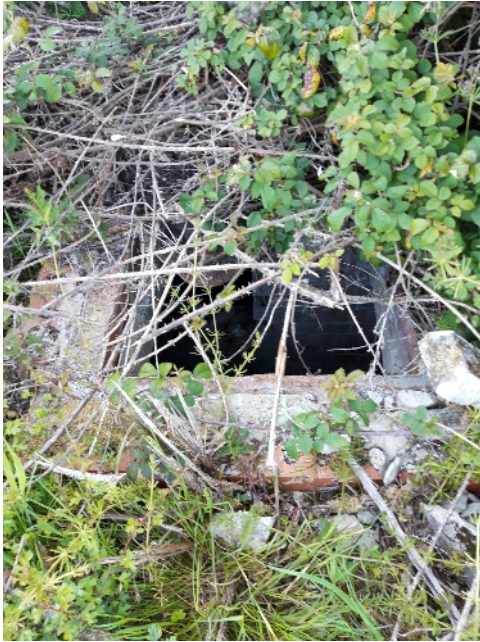
There is a manhole at the junction with the pipe leading from Linden Lea. This is shown in Photograph 5. At the time of writing the manhole cover and frame were displaced and there appears to be some damage within the manhole (Photograph 5a).

Photograph 5 - Manhole

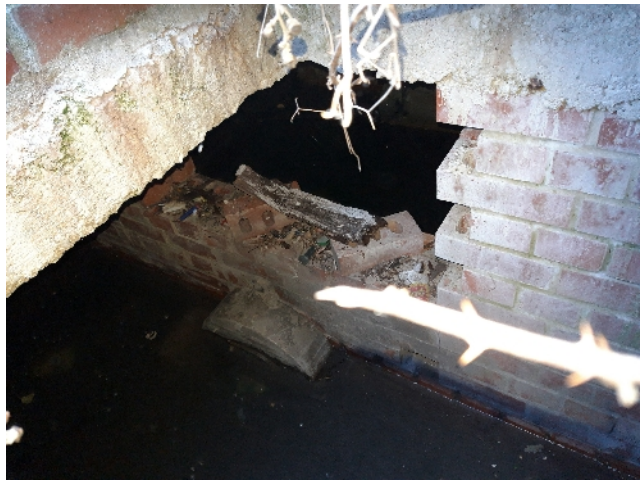
Photograph 5a - Inside the manhole

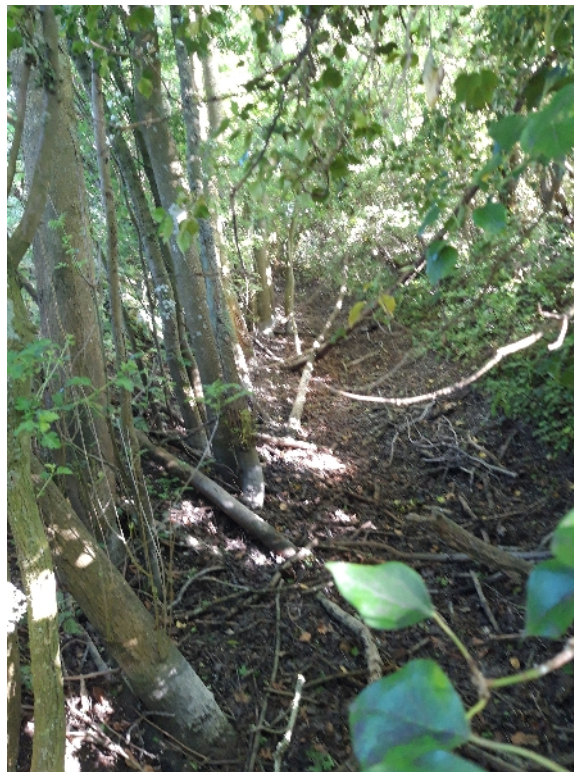
Photograph 6 is taken from further upstream near the start of Drain C at the end of Suffolk Place.

Photograph 6 - Drain C looking South

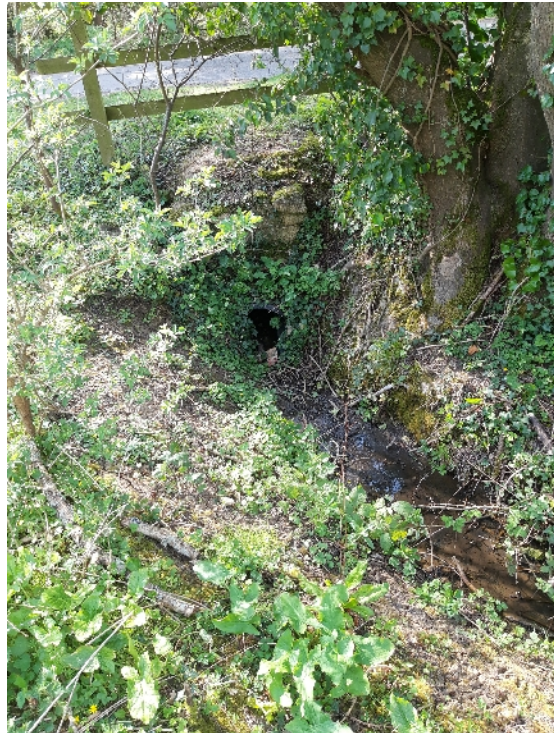
Photograph 7 is the start of Drain E from where the pipe joining Drain D to it passes under Oak Road.

Photograph 7 - Drain E Looking back to Oak Road

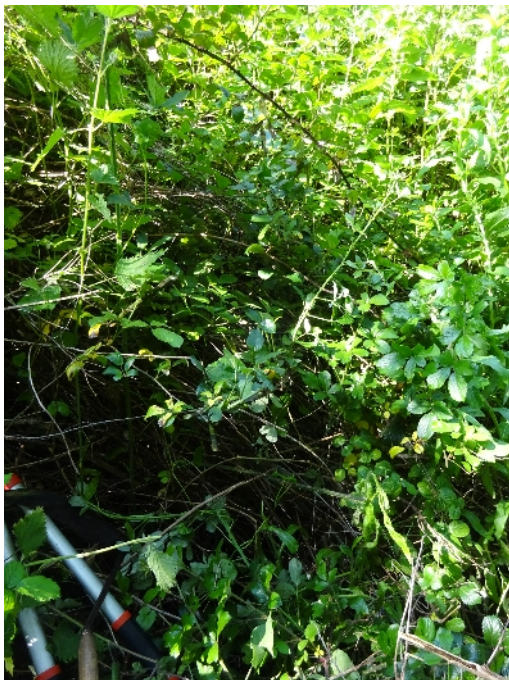
Photograph 8 - The point where the 9" pipe joins Drain E

Photograph 8 is where the 9" pipe mentioned above joins the Drain E. Drain E is very overgrown but after clearing the area it is possible to see a dry-stone headwall (Photograph 9). It was not possible to see the the pipe and confirm that it is 9" diameter pipe (see also the section on Pipe B).

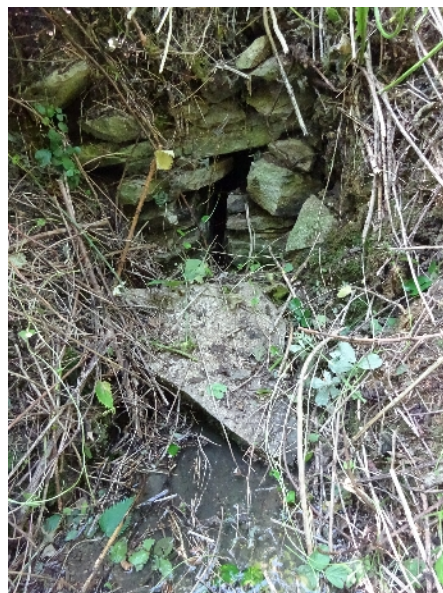
Photograph 9 - The headwall of the pipe joining Drain E after clearing

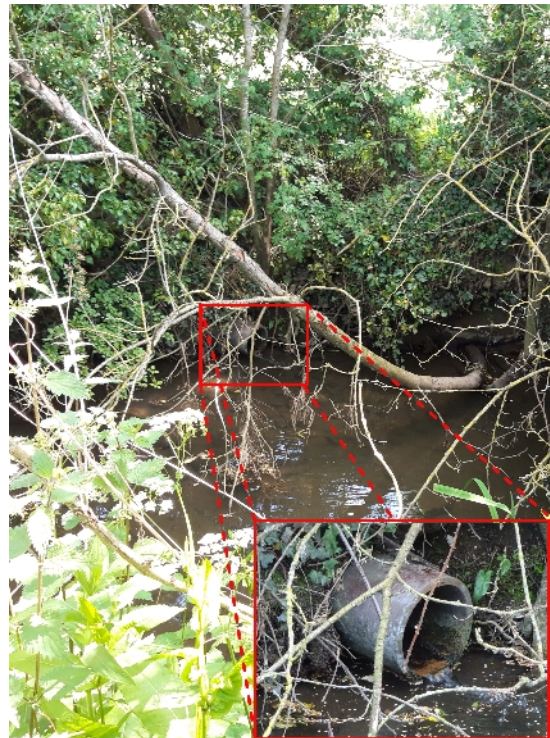
As was mentioned earlier under section 3 on Drain B the bottom end of Drain B2 and the highway drainage from Chestnut Close, Suffolk Place and the west end of Main Street outfalls into Poulton Brook (see Photograph 10). It is worth noting that water is flowing from the outfall despite there having been no rain for several weeks at the time of Photograph 10. It was noted that Poulton Brook is overgrown at this location and downstream to its confluence with Ampney Brook. From observation the outfall is a 12" pipe. The basic slope on the pipework must be in the region of 1 in 200; applying the Manning formula the maximum flow rate should be about 60 litres/sec.

Photograph 10 – Highway drain outfall into Poulton Brook

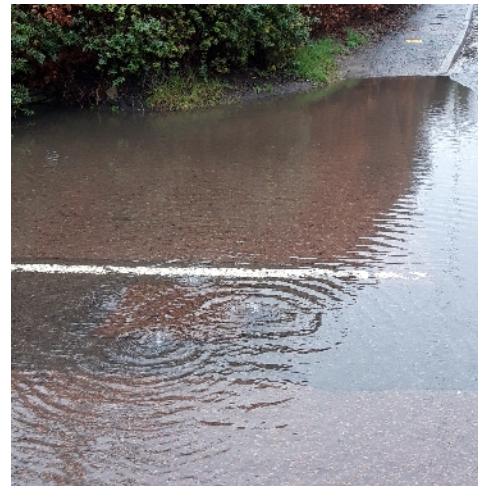
In times of heavy rainfall Poulton Brook runs bank full and standing water is observable from the Red House eastwards as far as Charlham Lane. On 30<sup>th</sup> January 2021 water could be seen bubbling from the manhole at the bottom of Charlham Lane (see Photograph 11). The head difference between this standing water and the water in Poulton Brook when this photograph was taken, however, would still be in the region of 0.5 metres (See next paragraph) therefore the flow rate should be nearly 40 litres/sec. This was clearly not the case when Photograph 11 was taken. A number of the gullies were not taking an appreciable quantity of water. The conclusion can only be that the road drainage pipes were blocked or restricted on that date. Cleaning and jetting was carried out at the beginning of February 2021. This may have solved the problem.

Photograph 11 - The end of Charlham Lane (31/01/2021)

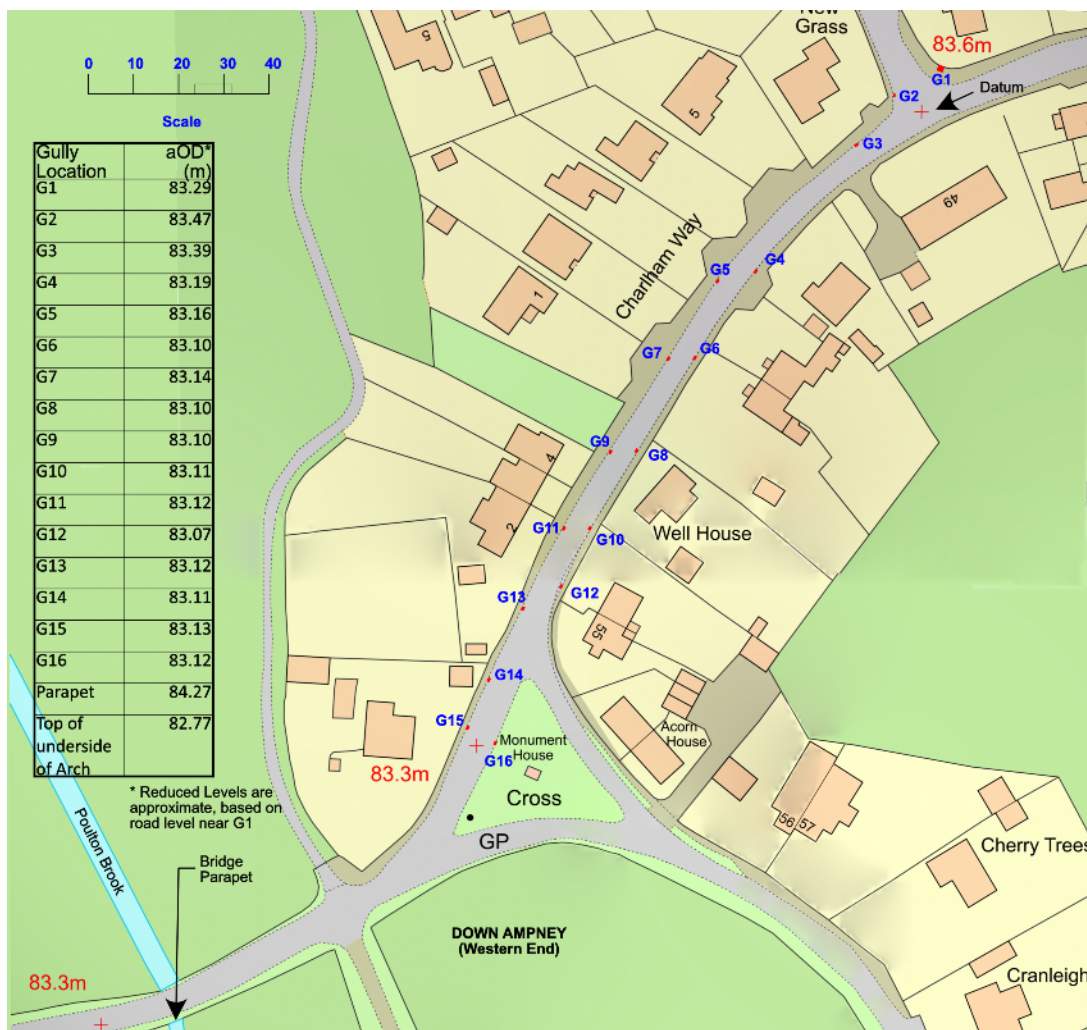
A level survey was undertaken by the author on 10 February 2021 to ascertain the relative levels of the gully gratings and Poulton Brook where the road drainage outfalls. The information is given below.

The minimum height difference between the lowest gully grating and the underside of the bridge at Poulton Brook is 0.3 metres. The author (resident in the village for 40 years) has never seen Poulton Brook this full even in the storm of July 2007. A realistic maximum would be 0.5 metre difference. This is still quite small but should be enough to prevent ponding between the Red House and the bottom of Charlham Lane, provided that the pipes are cleaned and jetted regularly and not just after a storm event when it is too late.

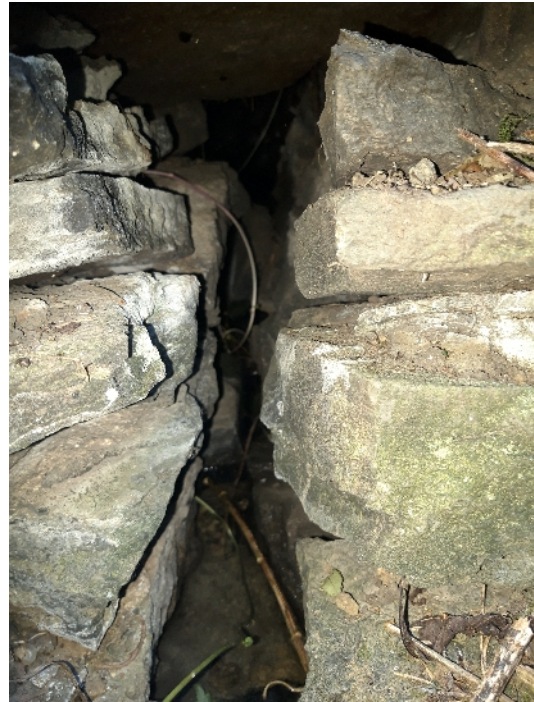
Pipe B is apparently a 9" clay pipe. The fall on the pipe is unlikely to be greater than 1 in 500. The flow rate calculated from the Manning formula is less than 20 litres/sec. As noted under the section on Drain E it was not possible to positively identify the size of the pipe because the outfall is a dry-stone construction with only a slit exit. Photograph 12 is an attempt to see behind the dry-stone headwall.

Photograph 12 – Inside the dry-stone outfall
