**RE: Objection to Cotswold District Council Tree Preservation Order TPO
No. 22/00005/IND Waterfront Tea Room, Victoria Street, Bourton on the Water
Gloucestershire, 2022**

15598 / 68259 Appendix 1. Site Photographs Waterfront Tea Room, Victoria Street, Bourton on the Water, Gloucestershire.

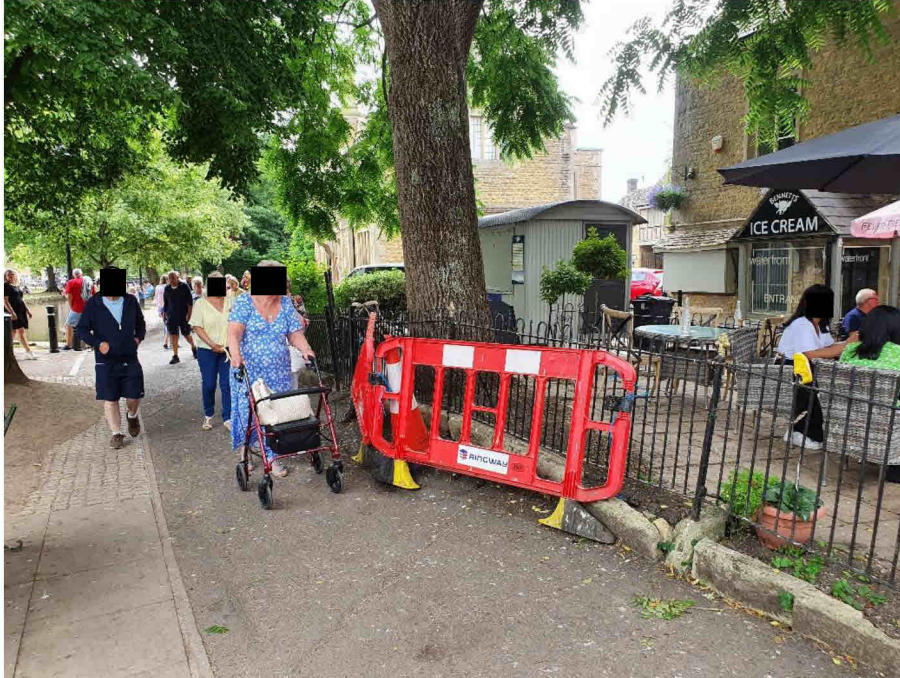
The Tea Room is adjacent to, and has a shared boundary and front garden/ serving area with, the Rose Tree Restaurant, a Grade II listed building (List No. 1088714). The continuous boundary consists of a low stone wall surmounted by iron hoop top railings with a pedestrian access to the north and matching pedestrian gate to the southeast (photograph 1)

Photograph 1. Front Boundary

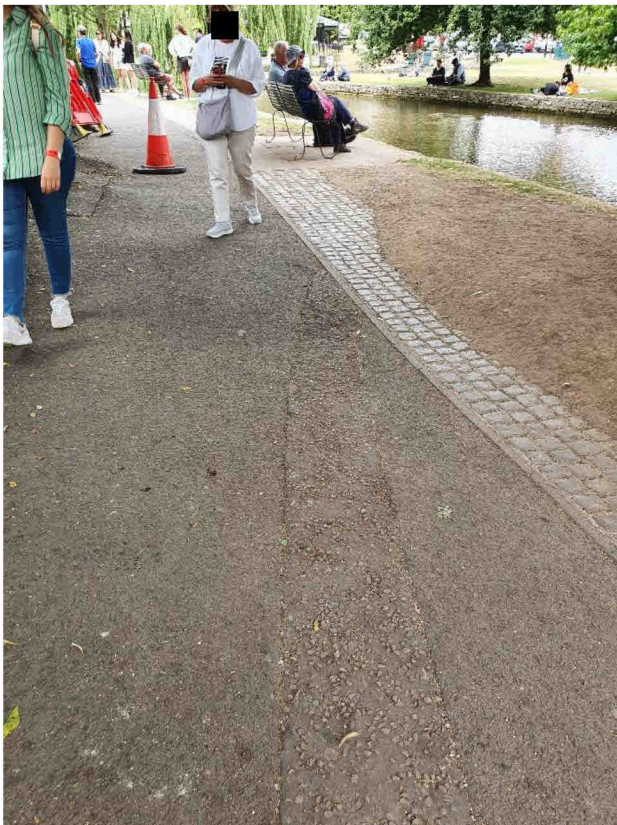
The 1.8-metre-wide, tarmac public footpath is located directly adjacent to the front boundary beyond which is a narrow 1.3-metre-wide grass verge and stone retained river bank of the River Windrush. The high use footpath is mainly level with service scars to the southeast of the tree and evidence of recent historic patching along the footpath edge (photograph 2).

Photograph 2. Footpath (with service scar) and verge

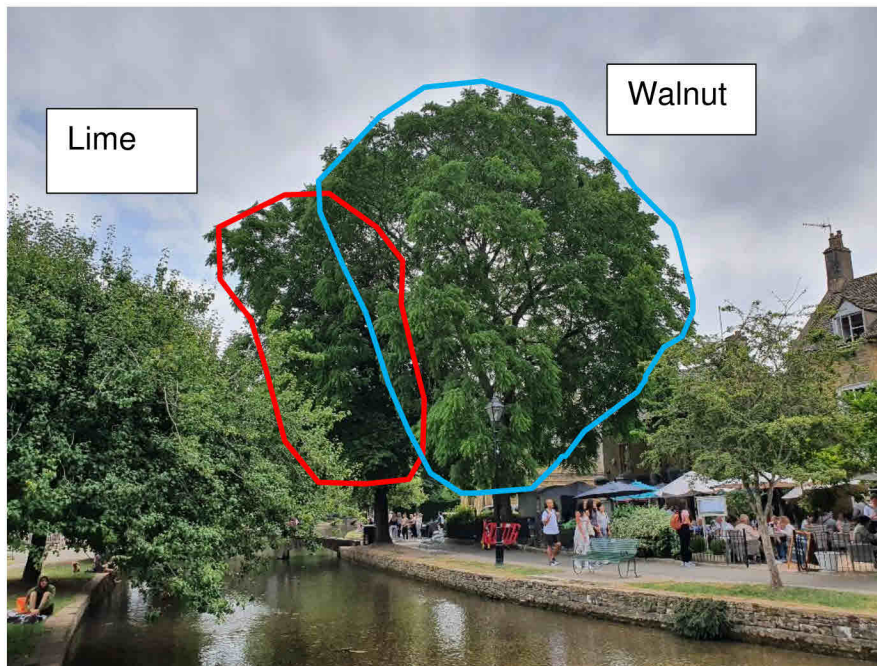
The Walnut (Blue outline photograph 3), although one of the larger trees in this area, is only one of a number of trees along the river corridor which includes a council-owned, developing semi mature Lime (Red outline photograph 3) around 3 metres to the southeast (photograph 3).

Photograph 3 Walnut and Lime

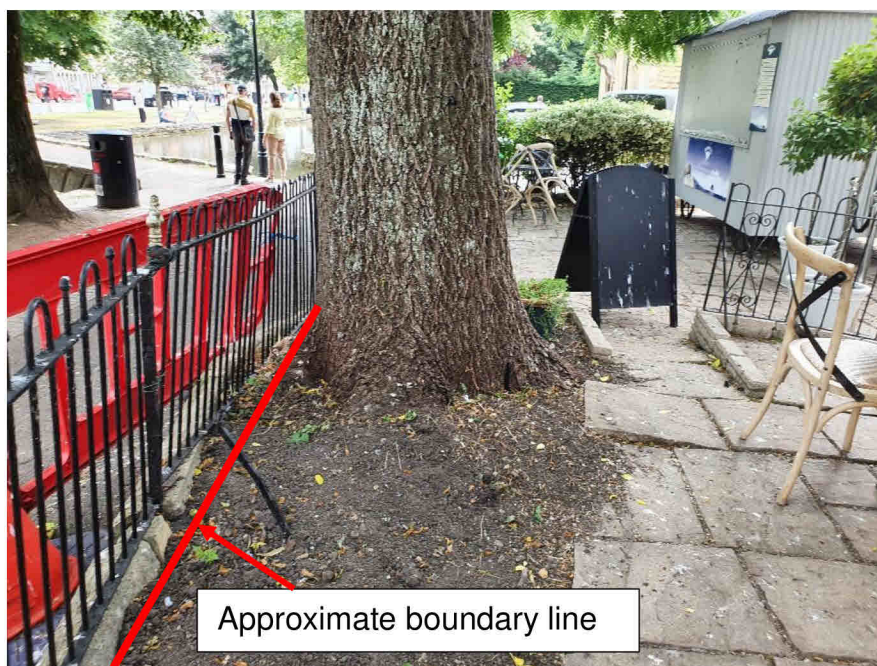
The tree has displaced the stone boundary wall by around 150mm into the public footpath and is starting to displace the railings which have already been broken and are now held together with a temporary repair (photograph 4).

Photograph 4. Boundary displaced into footpath

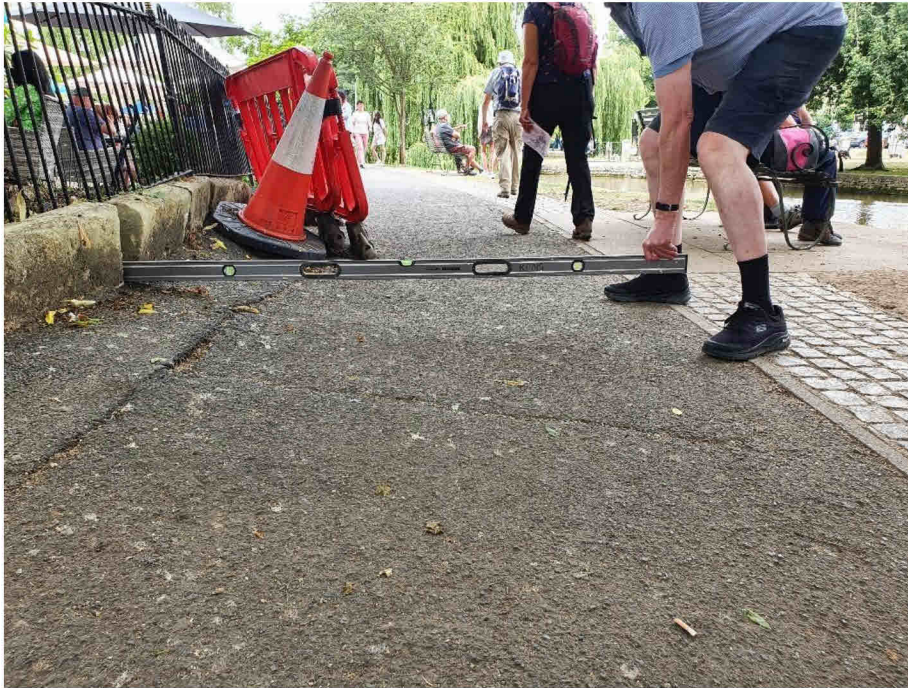
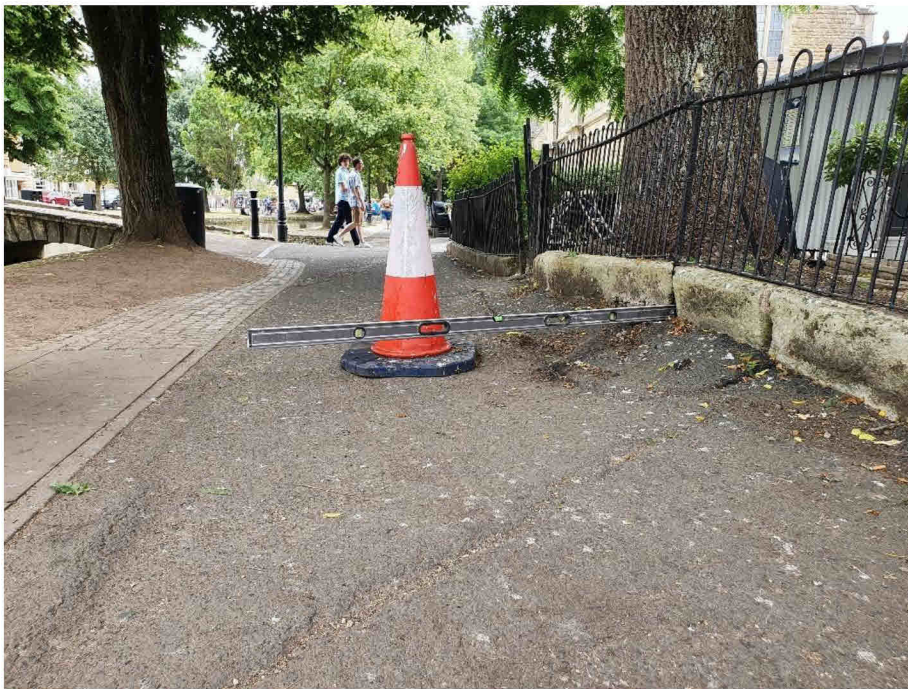
Around a one-third of the width of the, mainly flat, footpath surface has been displaced upwards by as much as 200-300mm, immediately adjacent to the tree, tapering down towards the centre of the footpath. In addition, there are radiating cracks extending across the remainder of the path surface. This damage is on-going and has been repaired in the recent past, but the path continues to be displaced (photographs 5 and 6).

Photograph 5 and 6. Vertical displacement of footpath and developing radial cracks

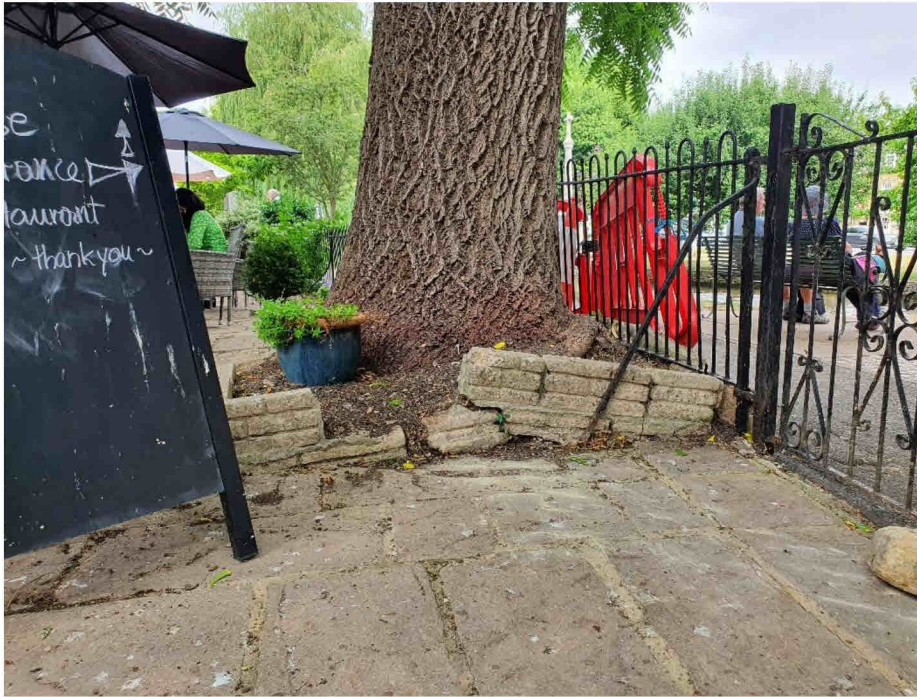
The internal raised seating area's retaining wall has been pushed substantially upward and out to the south. Paving within the seating area is being displaced, creating a trip hazard and limiting the use of the area (photograph 7).

Photograph 7. Displacement of internal retaining wall and paving.

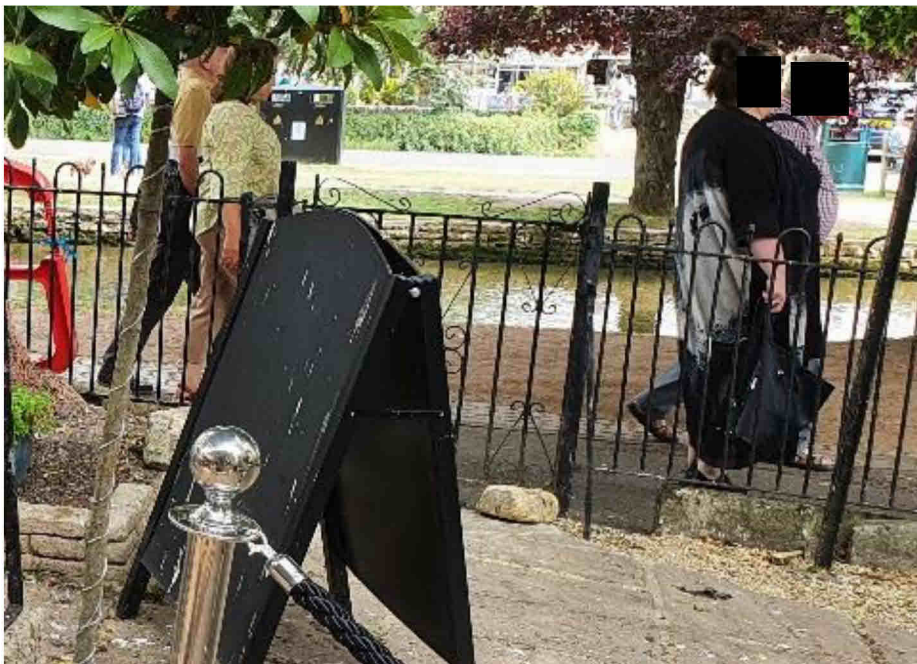
The gate pillar for the pedestrian access gate to the south of the tree has been displaced and no longer closes (photograph 8). Paving across the pedestrian access for the raised seating area has been displaced and can no longer be used safely due to the trip hazard caused. Increasing levels either of the footpath or paving to limit damage would be difficult to achieve and likely to create further trip hazards or limit access from the public footpath.

Photograph 8. Displaced pedestrian gate access
