17/00206/TPO (06/00158/TPO)

**Beeches Car Park
Beeches Road
Cirencester
Gloucestershire**

Various tree works to 6 trees (1x Ash 3x Lime 2x Norway Maple) at Beeches Car Park Beeches Road Cirencester Gloucestershire

Cirencester, Beeches Car Park

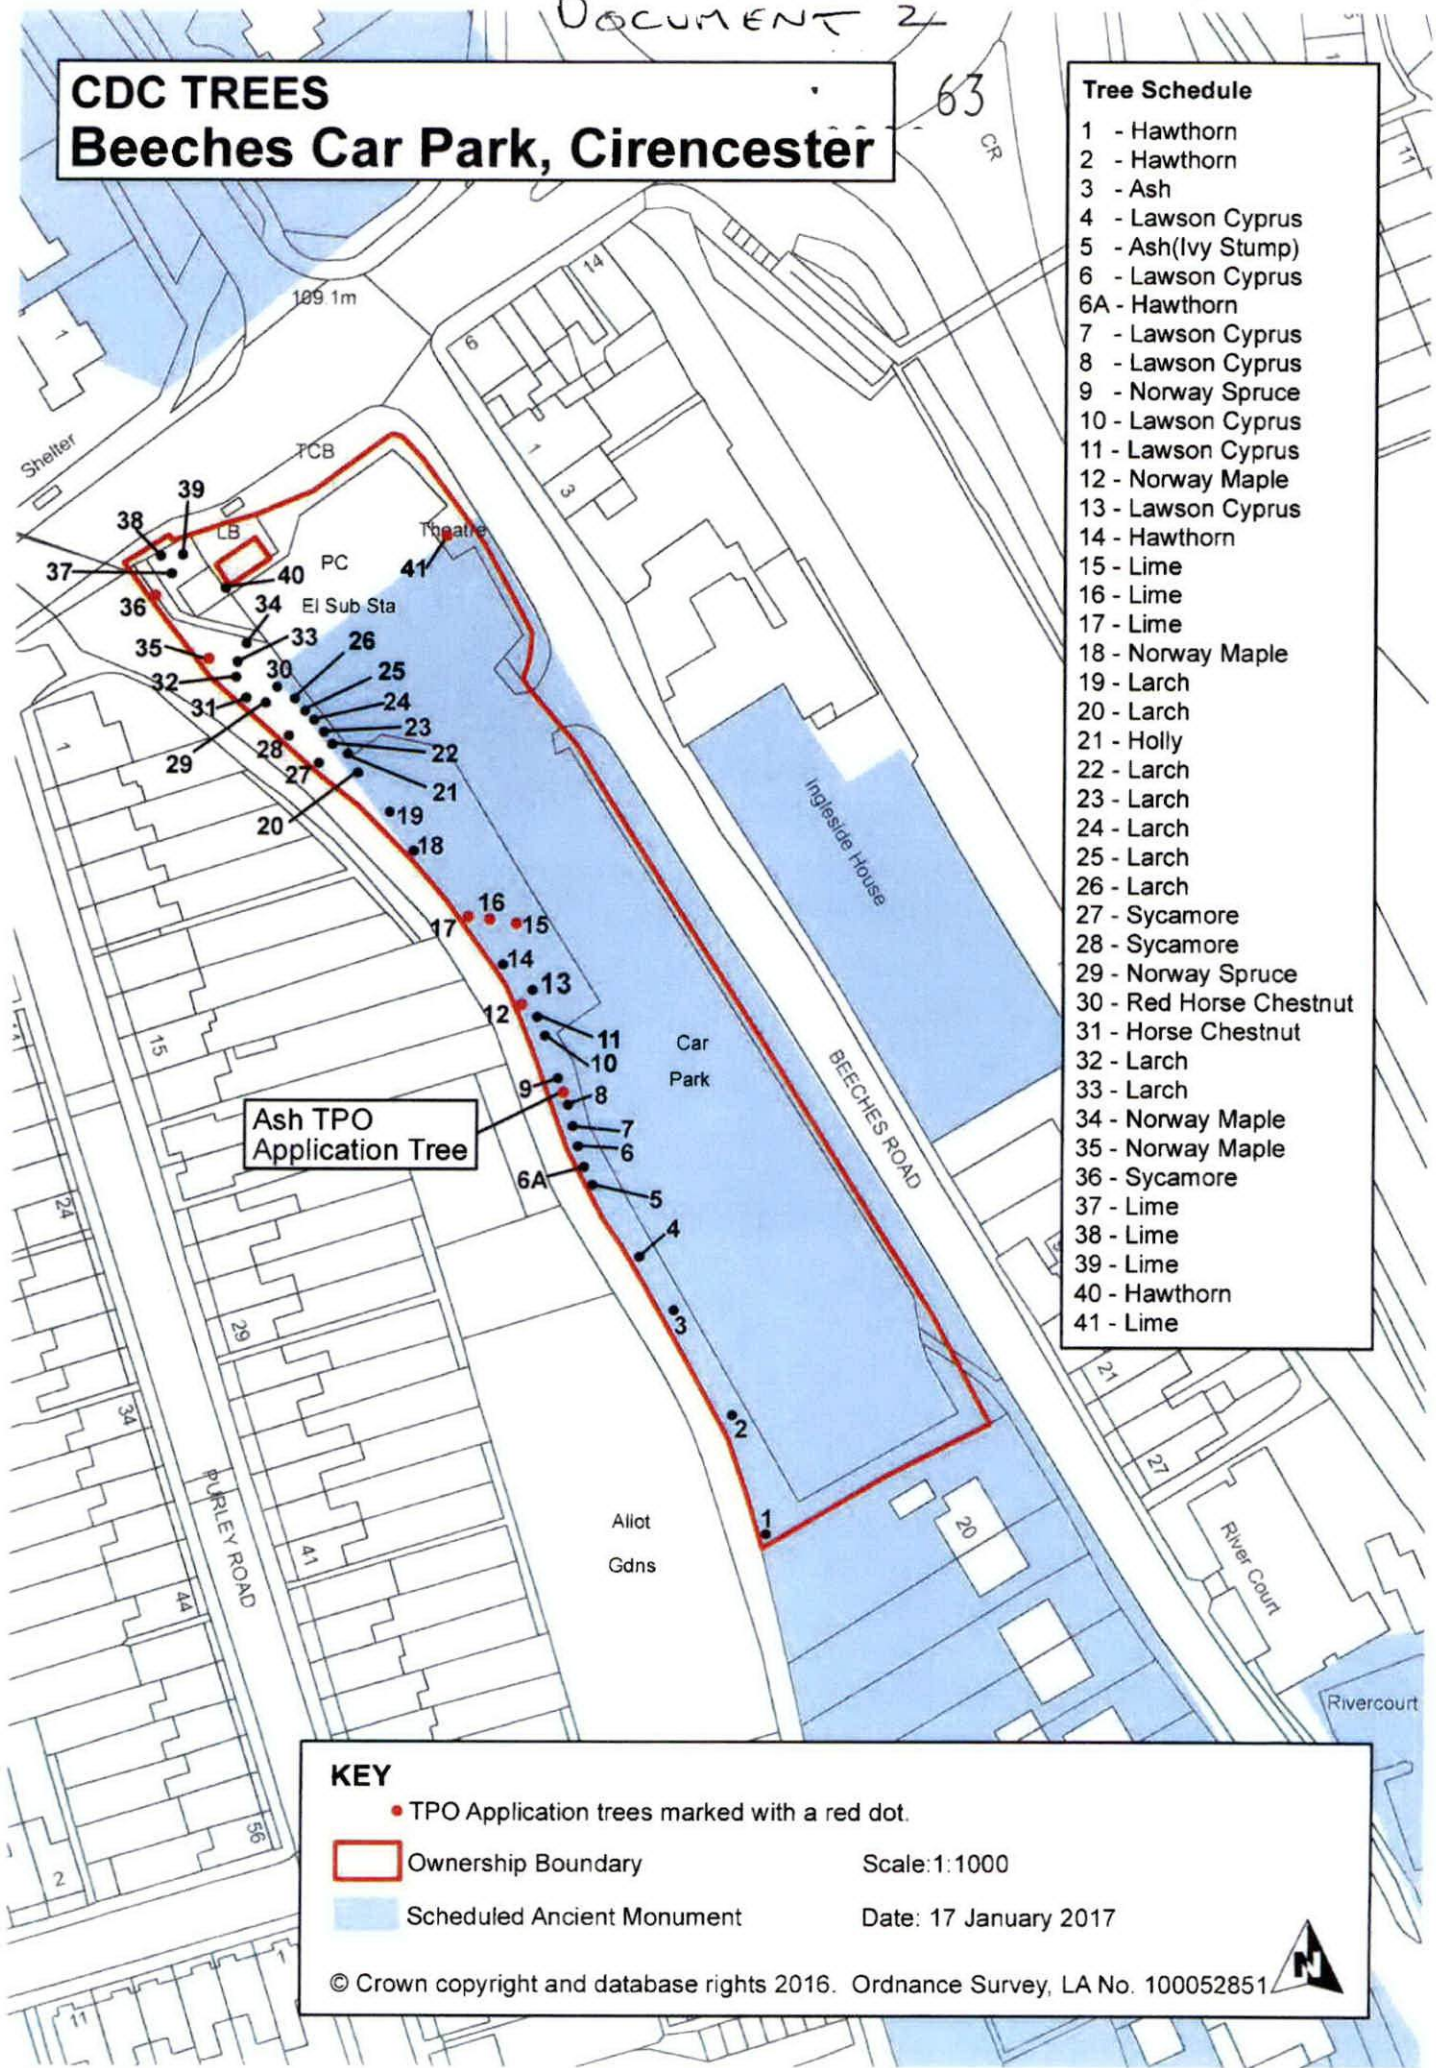
CDC TREES Beeches Car Park, Cirencester

Ash TPO Application Tree
