Figure E-3 Borehole B5 Cuttings

Appendix F NP Policy Example

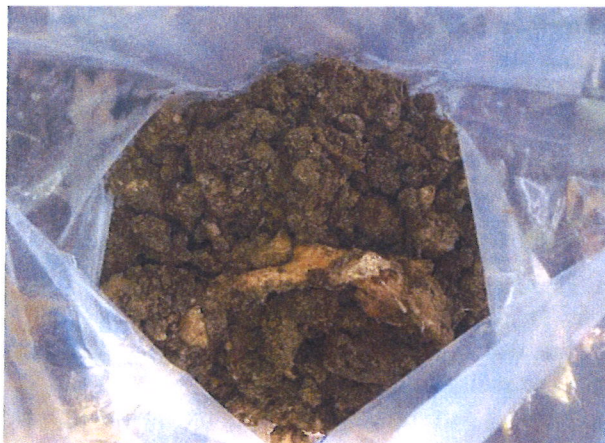
D-1 Borehole B5 cuttings 0.50-0.60 mbgl

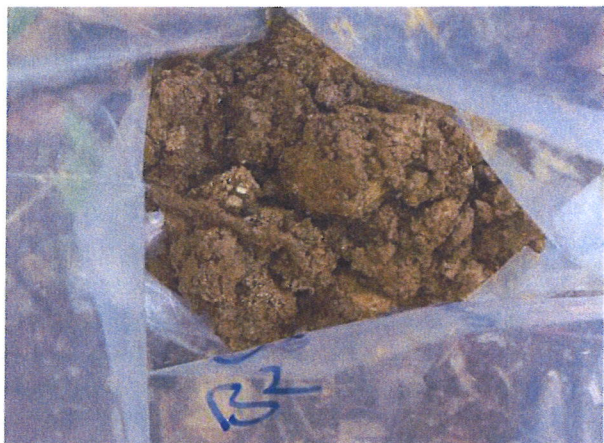
D-2 Borehole B5 cuttings 0.60-0.70 mbgl

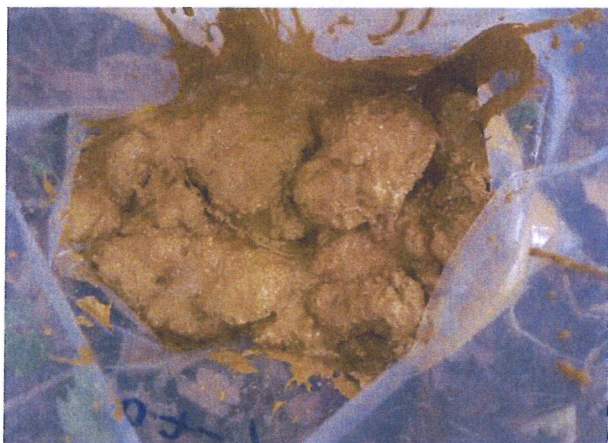
D-3 Borehole B5 cuttings 0.70-1.80 mbgl

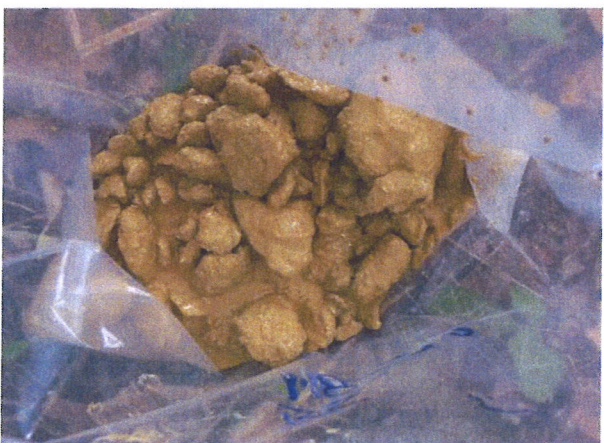
D-4 Borehole B5 cuttings 1.80-2.20 mbgl

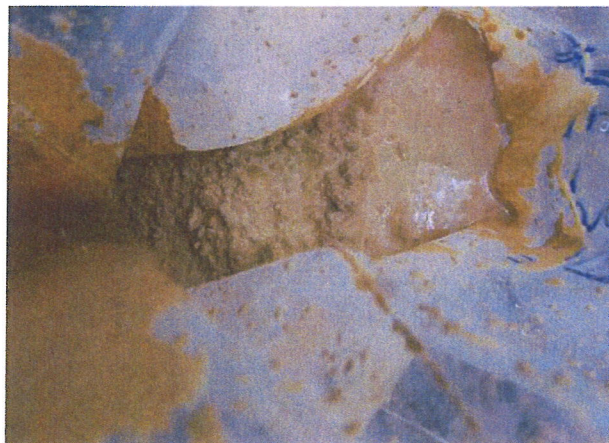
D-5 Borehole B5 cuttings 2.75-3.40 mbgl

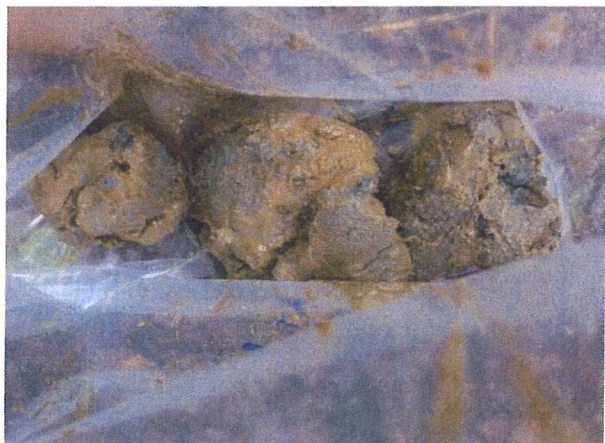
D-6 Borehole B5 cuttings 3.40 - 4.10 mbgl
