## **ANNEXE C – SURFACE WATER DRAINAGE SURVEY APRIL TO JUNE 2020**

**(with amendments and additions to February 2021)**

Carried out by  
Andrew Scarth CEng FICE

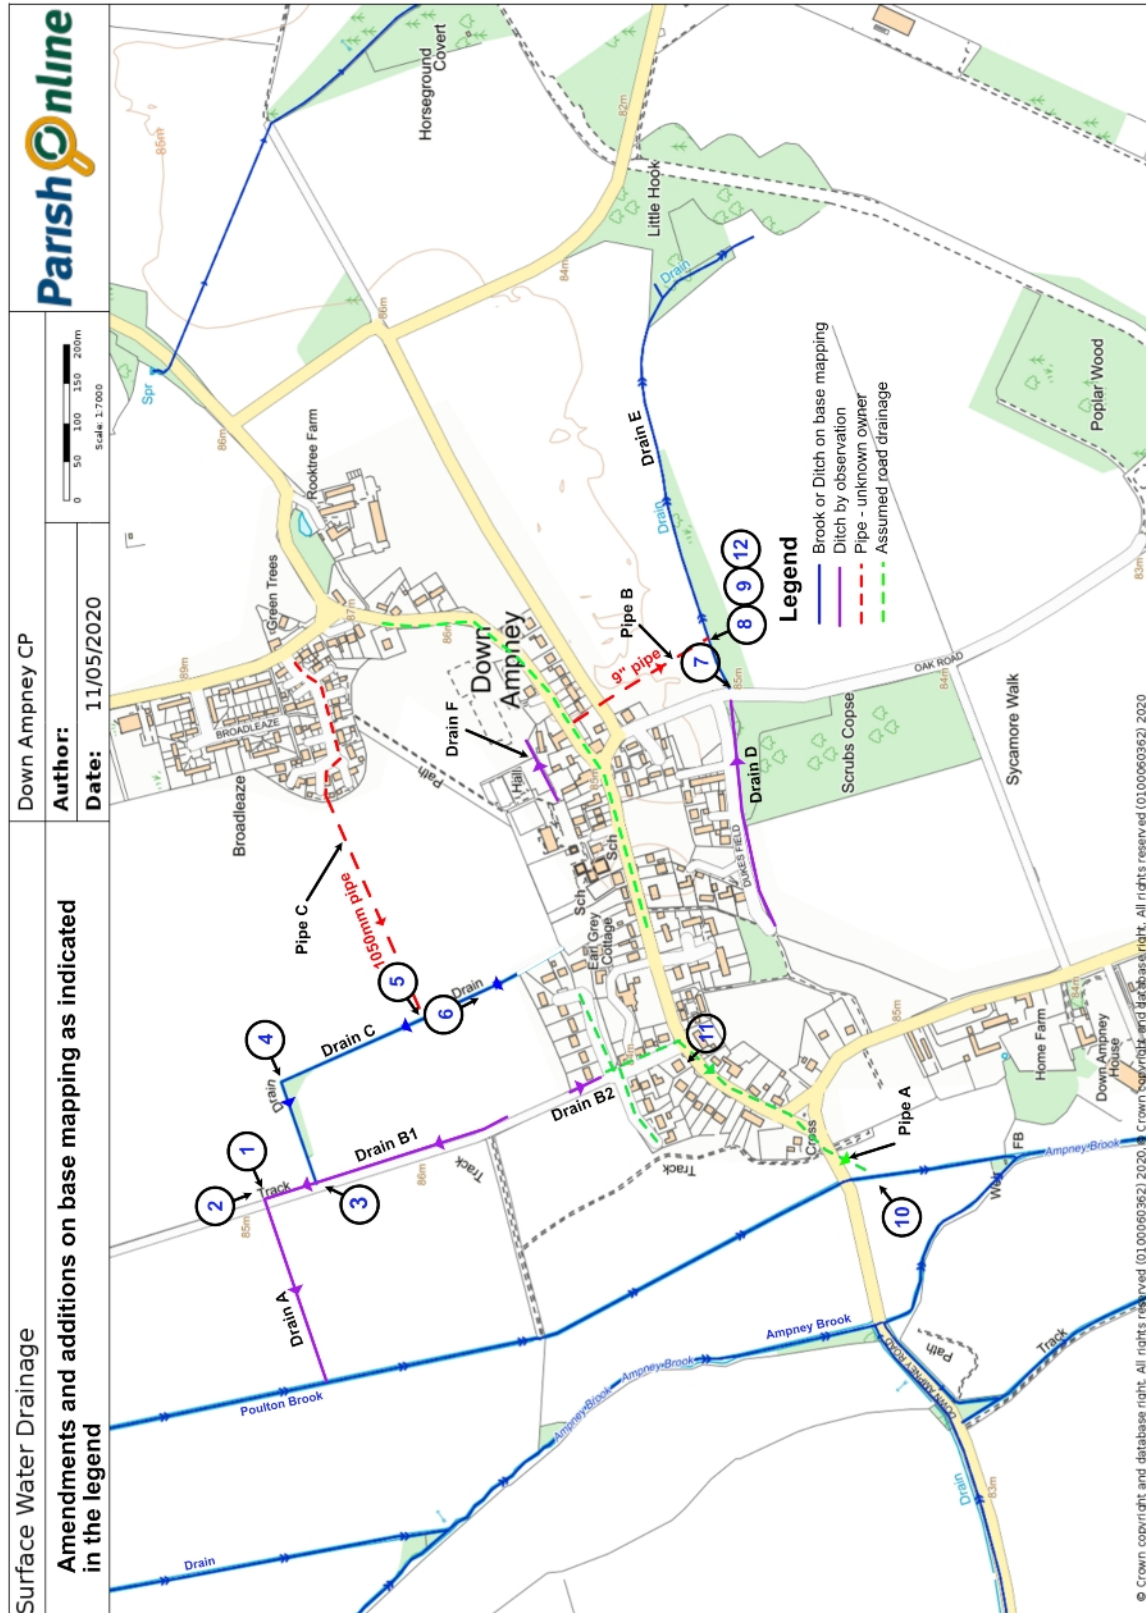
Drain B1 runs beside the Charlham Lane track. It flows northwards past its junction with Drain C to Drain A flowing under the track via a pipe. Drain B2 flows southward to a headwall and 300 mm diameter pipe next to 1 Suffolk Place. From there it is assumed to join the highway drainage system which eventually outfalls into Poulton Brook just to the west of the village. It is not clear whether there is a pipe connecting Drain B1 to Drain B2.

At the time of writing the Drain B1 is blocked between its junction with Drain C and its junction with Drain A. The drain and the obstruction can be seen in Photograph 2.

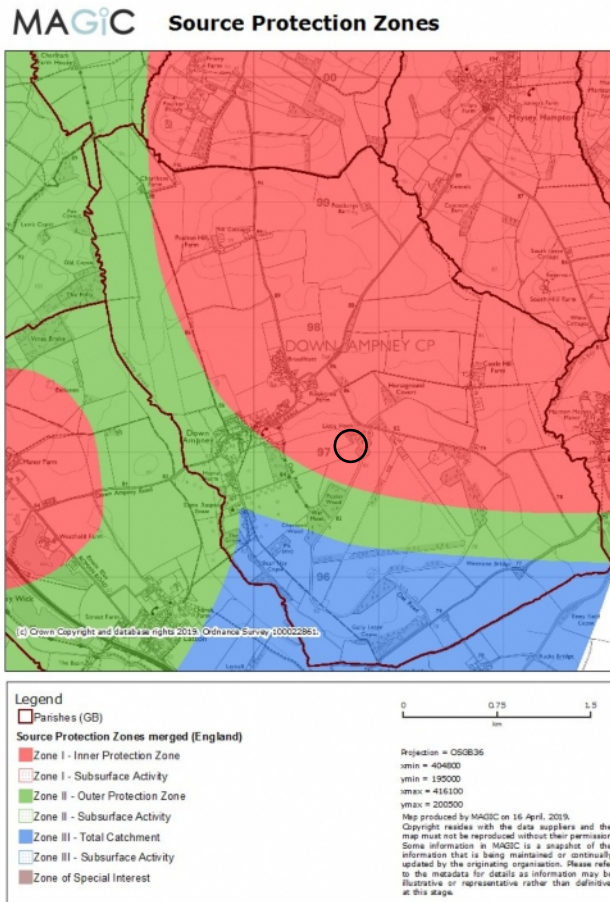
Drain E terminates at the woodland of Little Hook near the north-east of the old airfield. This area is within a groundwater Source Protection Zone 1 designated by the Environment Agency for water resources.
