Item No 07:-**Re-roofing of back slope to main house at Chester House High Street Fairford
Gloucestershire GL7 4AD**

Listed Building Consent 18/02869/LBC	
Applicant:	Mr & Mrs M Lee-Browne
Agent:	Michael Grosscurth (Surveys) Ltd
Case Officer:	Mark Smith
Ward Member(s):	Councillor Andrew Doherty
Committee Date:	12th December 2018
RECOMMENDATION:	REFUSE

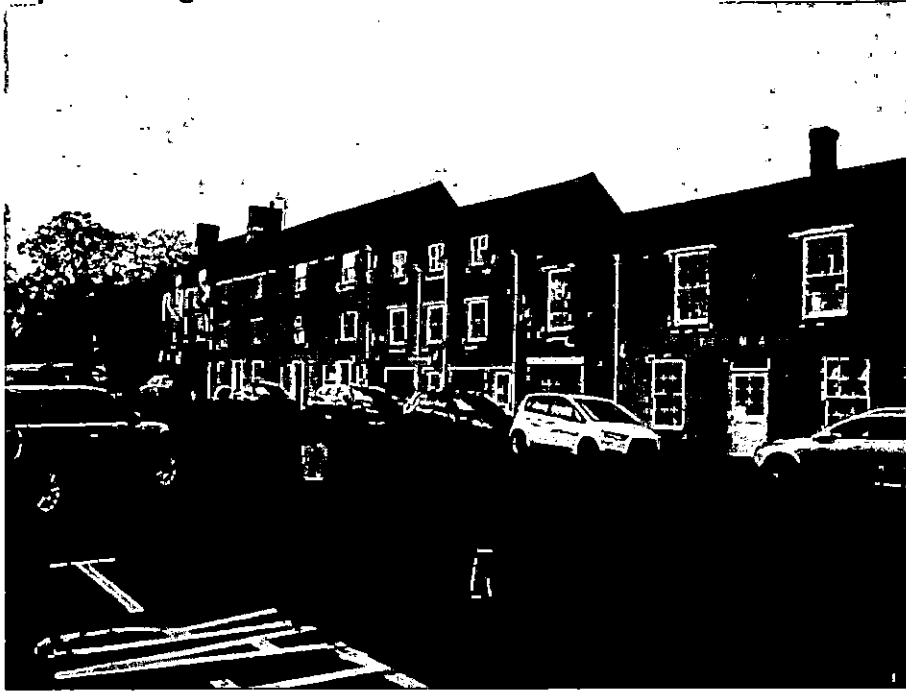
Top end of High Street

- 2 blue slated roof slopes
- 2 different roof pitches to blue slated sections

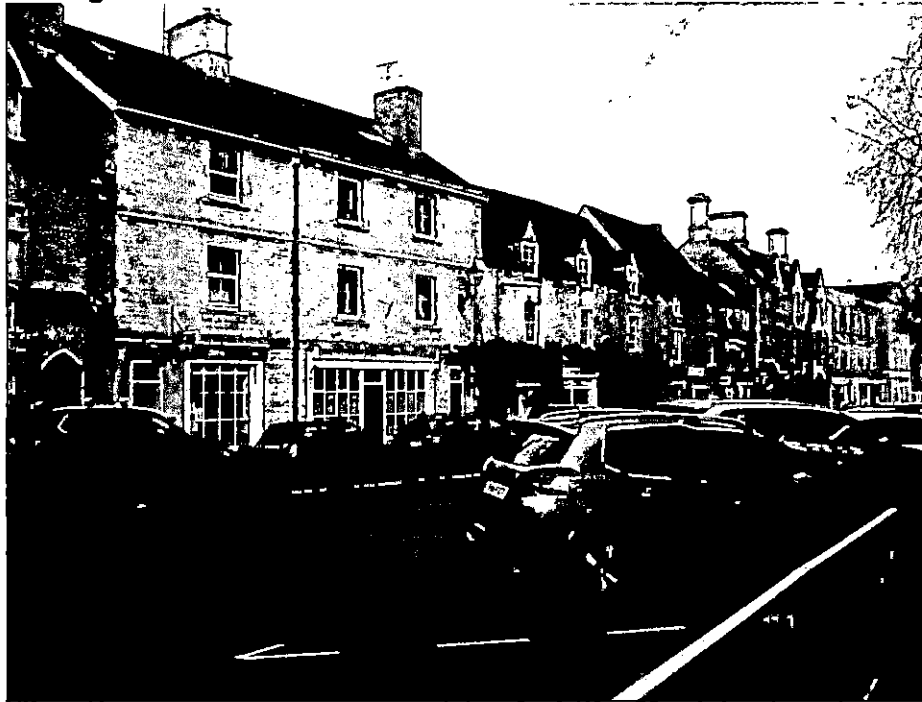
Mid High Street

- 2 blue slated sections
- 2 different pitches

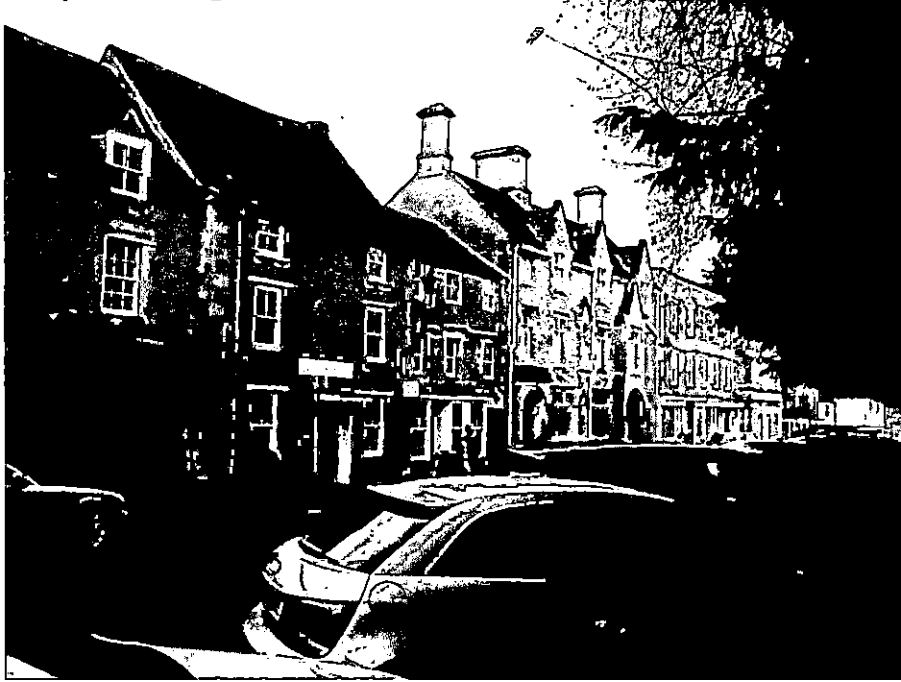
3. **Subject building**

- o Blue slated front slope at 35 degrees

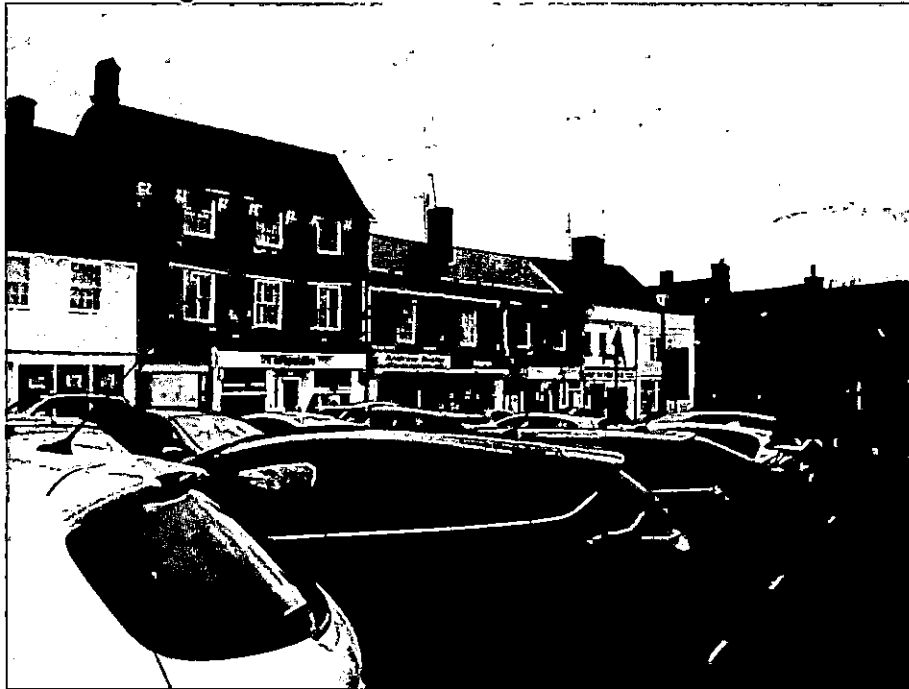
4. **Lower end High Street**

- o Recent blue slated pitch
- o Plus other blue slated slopes to London Street
