**14/04215/FUL (CD.1580/7/F)**

**Building 10  
Smith Barry Road  
Upper Rissington  
Gloucestershire**

**Demolition of Officers Mess Central Core and erection of 12x4 bed and 2x2 bed residential units. Erection of 16 carports and provision of frontage parking at Building 10  
Smith Barry Road Upper Rissington**

**Structural Re-inspection Report of Main  
Three Storey Central Block**

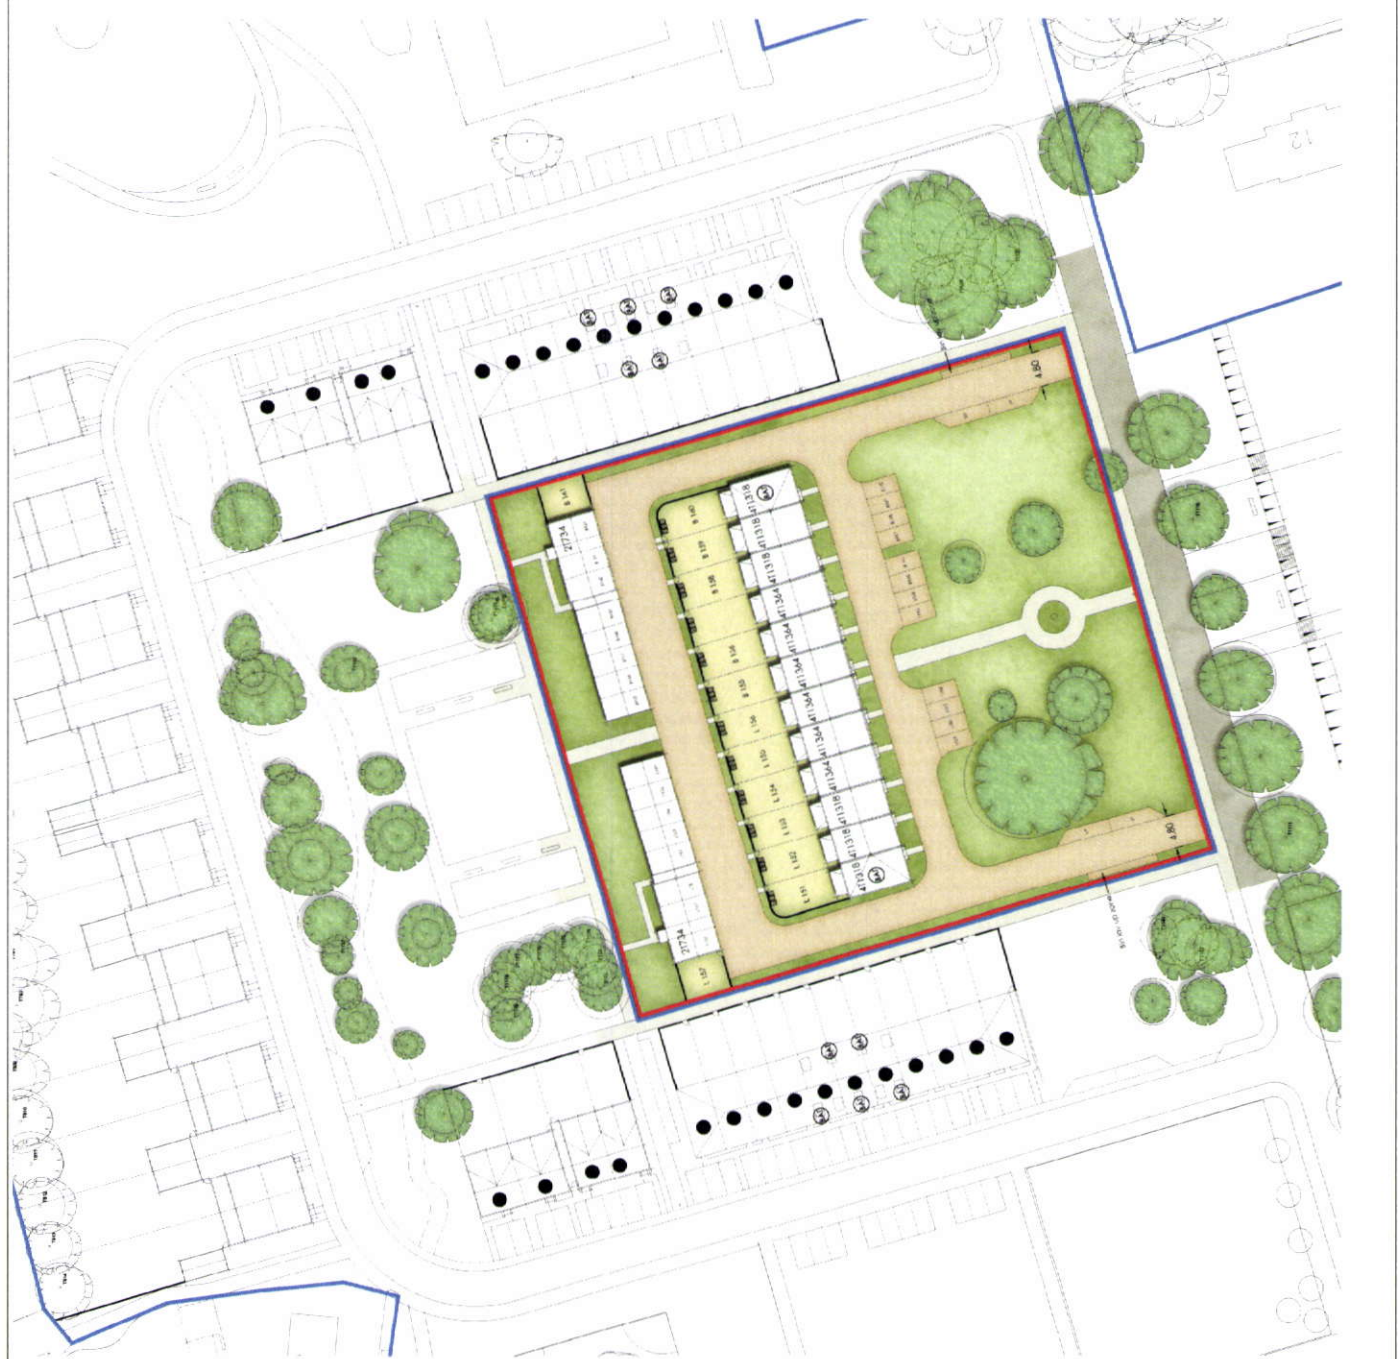
- Existing tree to be retained (with associated RPA)
- Proposed 1.8m high screen wall
- Proposed 1.8m high timber gate (access to gardens)
- Proposed 1.8m high timber panel fence (fencing between housing)
- L01 Plots prefixed with an L = Linden Homes
- B01 Plots prefixed with an B = Bove Homes
- Vp Visitor parking space
- Indicative bin storage location
- Access points to bat lifts

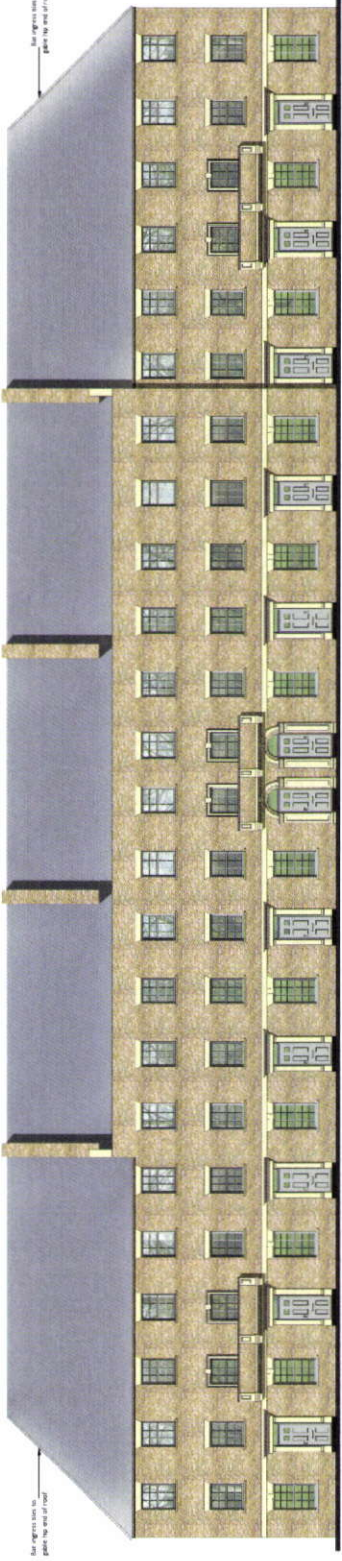
Front Elevations

Side Elevations

Rear Elevations
