FORMAL CONSULTATION DRAFT SOMERFORD KEYNES CONSERVATION AREA APPRAISAL

1. Introduction

2. Character assessment

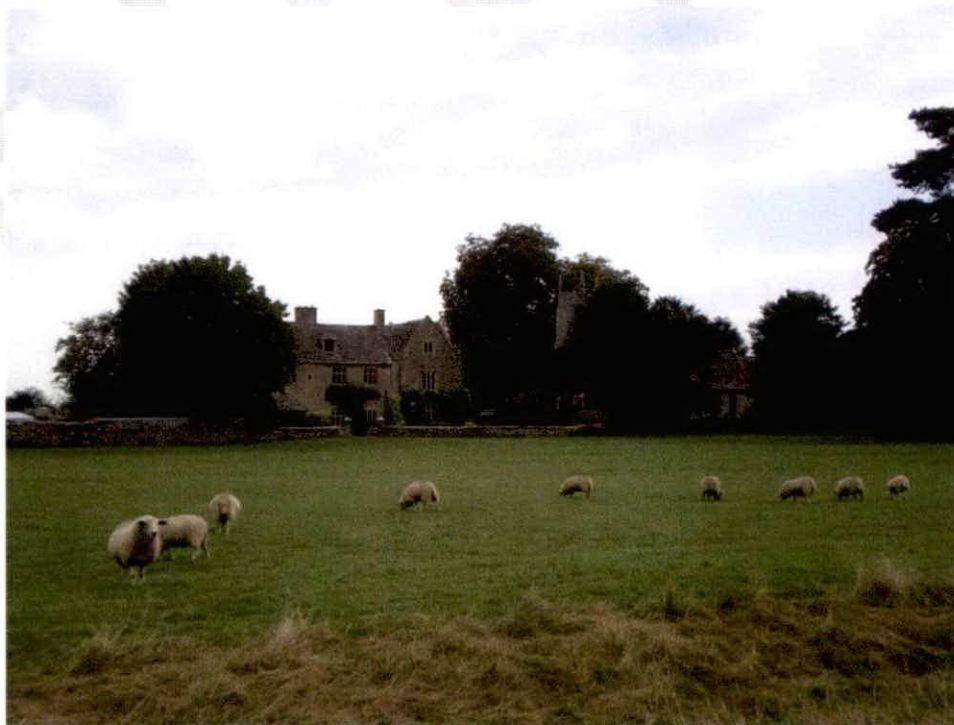
Figure 1: *View north towards the Manor House and Church, from the public footpath that crosses their historic parkland setting.*

- 2.2.3 This important open space relates visually and historically to the Manor House, the Church and Somerford Keynes House. Map evidence shows this area to have historically been parkland to the Manor House. Formerly an avenue of trees extended from the south elevation of the Manor House, terminating at the proposed southern boundary edge. Although the avenue has been removed, some mature trees survive. To the west of the Manor House is an historic fishpond, which most likely related to the Manor Farm Complex.

- 2.2.4 There is a clear visual inter-relationship between the area of former parkland and the surrounding listed buildings. To the Manor House just a low wall separates the two, containing an opening that would have led on to the avenue of trees. The western edge of the garden to Somerford Keynes House bounds the open space and features a ha-ha, designed to give the house a pleasing parkland aspect.

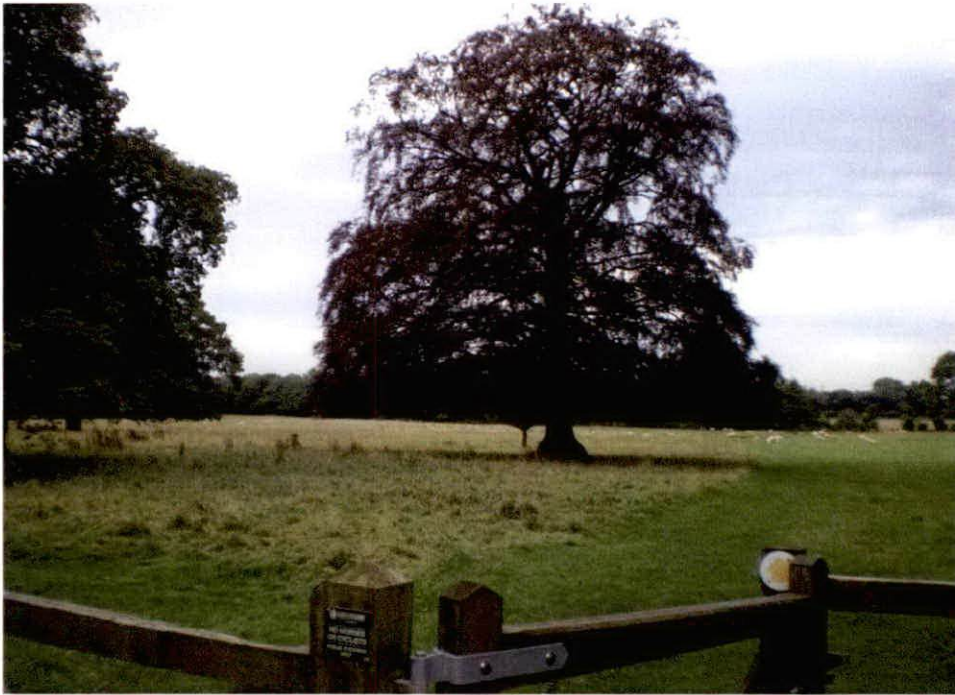
Figure 2: *View south west from the gateway adjacent to the Church, along the public footpath, showing one of the mature historic parkland trees.*

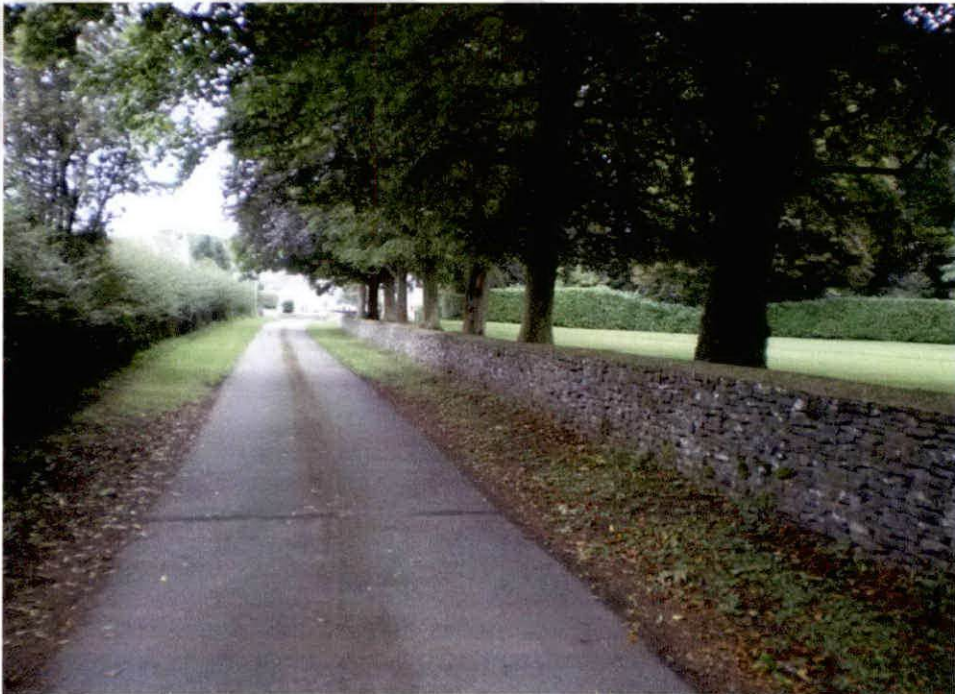
Figure 3: *View east along the lane from the Church.*

- 2.2.5 There is an important open space to the north of Somerford Keynes House, containing the sweeping driveway to this former vicarage. Trees line a lane to its north, which is also enclosed by dry stone walling, hedging and grass verges. From the lane there are views across the green open space towards Somerford Keynes House. A footpath crosses the southern edge of the space, connecting the Church and the main street.

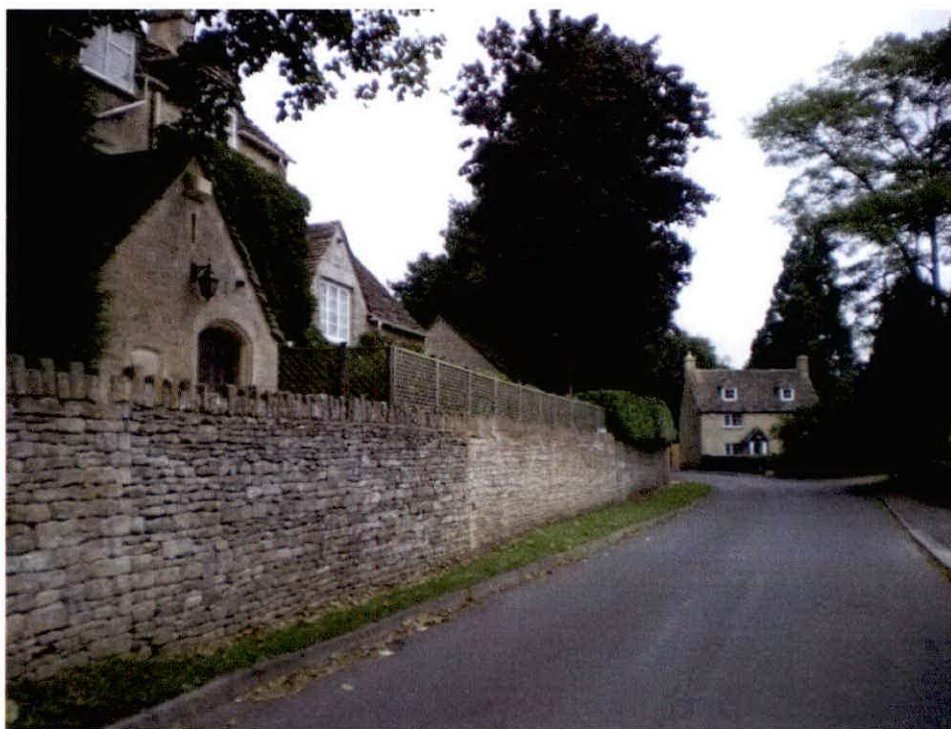
Figure 4: *View north from Croft House, along the main village street, towards Croft Cottage.*

2.2.6 The second character area is larger and comprises the main village street. Although the settlement pattern here is linear, there are gentle curves in its route through the village. This creates points where views down the street terminate, for example where Croft Cottage forms a focal building in views from the south.

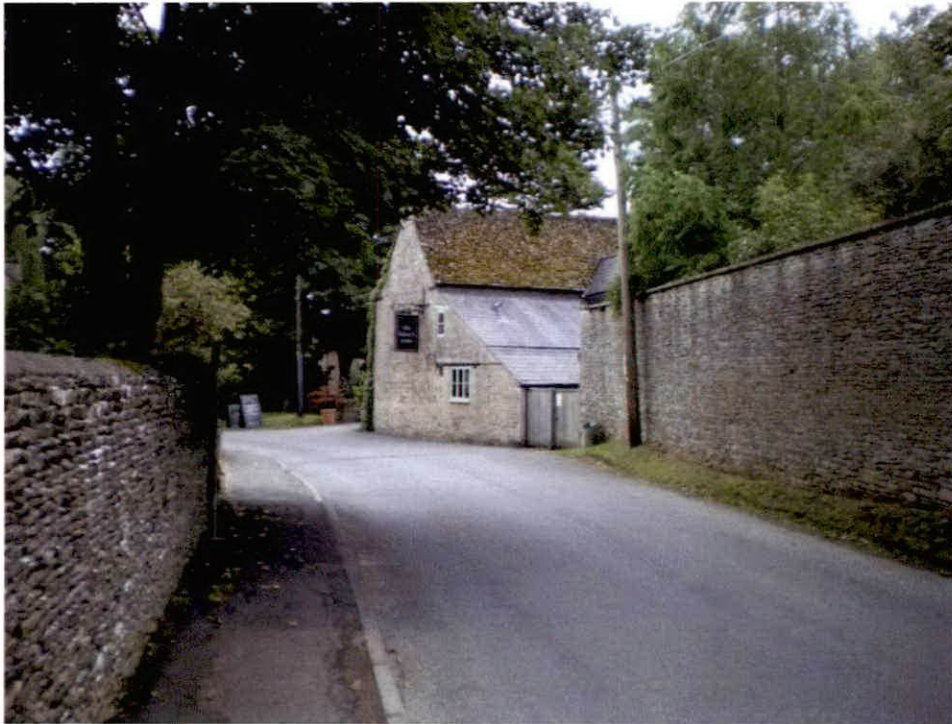
Figure 5: *View south along the main village street, towards The Bakers Arms, showing high enclosing walls and mature trees.*

2.2.7 Historically buildings were fairly dispersed along the main street, separated by orchards and gardens. In the twentieth century a number of houses have infilled these spaces. These tend to follow the linear pattern of the settlement but, unlike the historic buildings which are set directly on or close to the street, they are often set further back within their plots. Generally a strong sense of enclosure is maintained all along the main street, with stone front boundary walls.

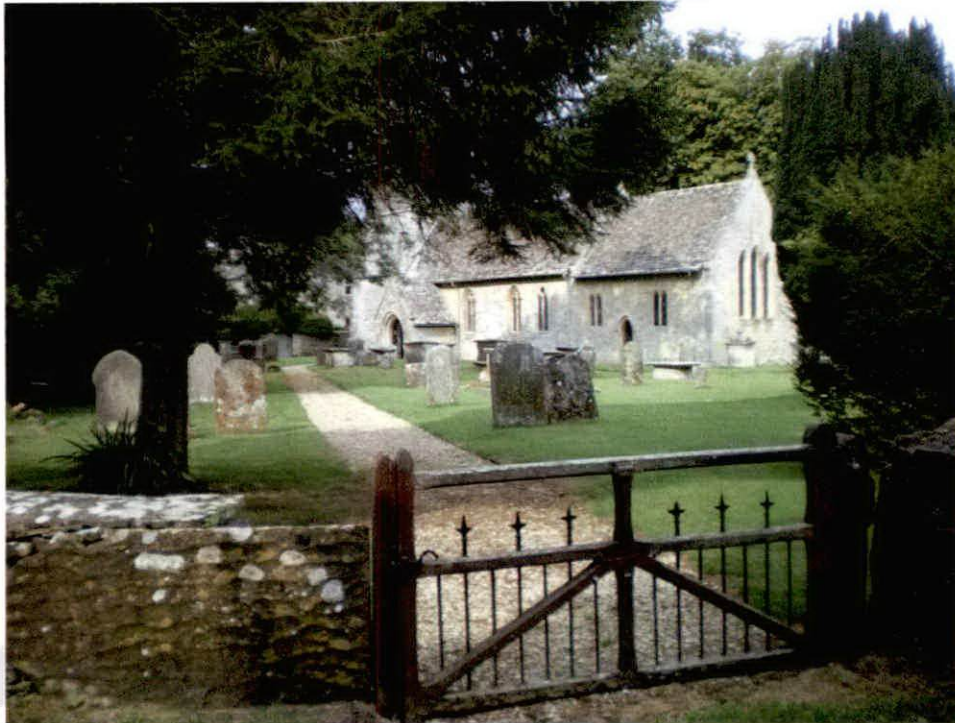
Figure 6: *The Church of All Saints is Grade II* Listed and has Norman foundations, with fourteenth century alterations and nineteenth century restoration works. There are numerous listed chest tombs and other monuments within the churchyard.*

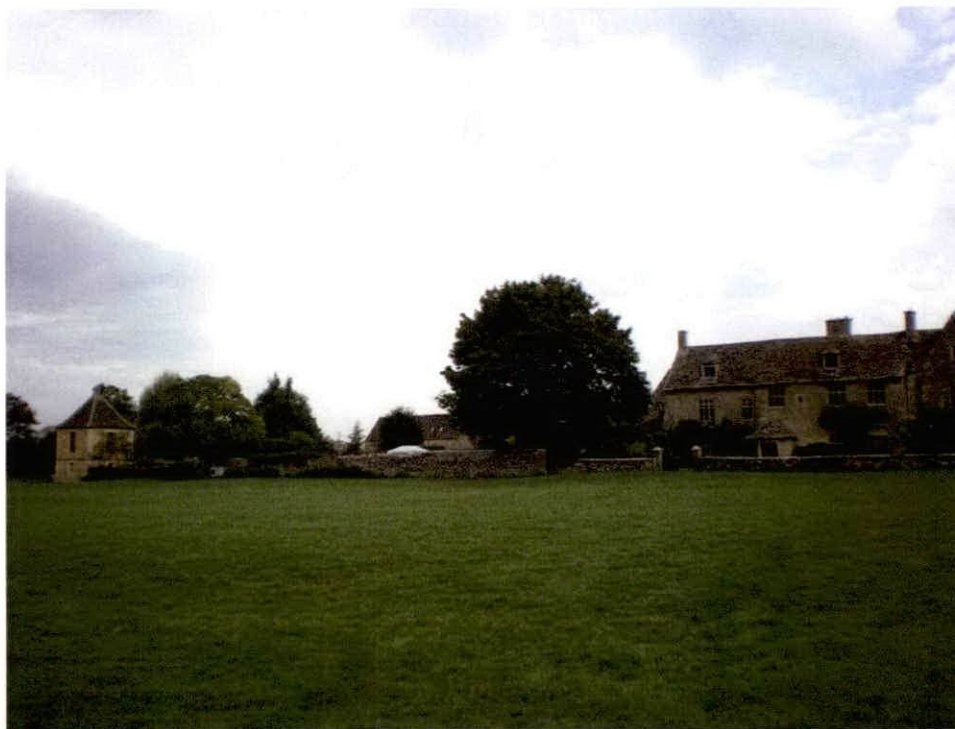
Figure 7: *The Manor House is Grade II Listed and dates to at least the sixteenth century, but it is largely seventeenth century. It is typical of a higher status Cotswold vernacular house of that period, with stone tiled roof, large gables, stone cross-mullioned windows and Tudor-arched doorways. To the west there are further listed farm buildings relating to the Manor.*

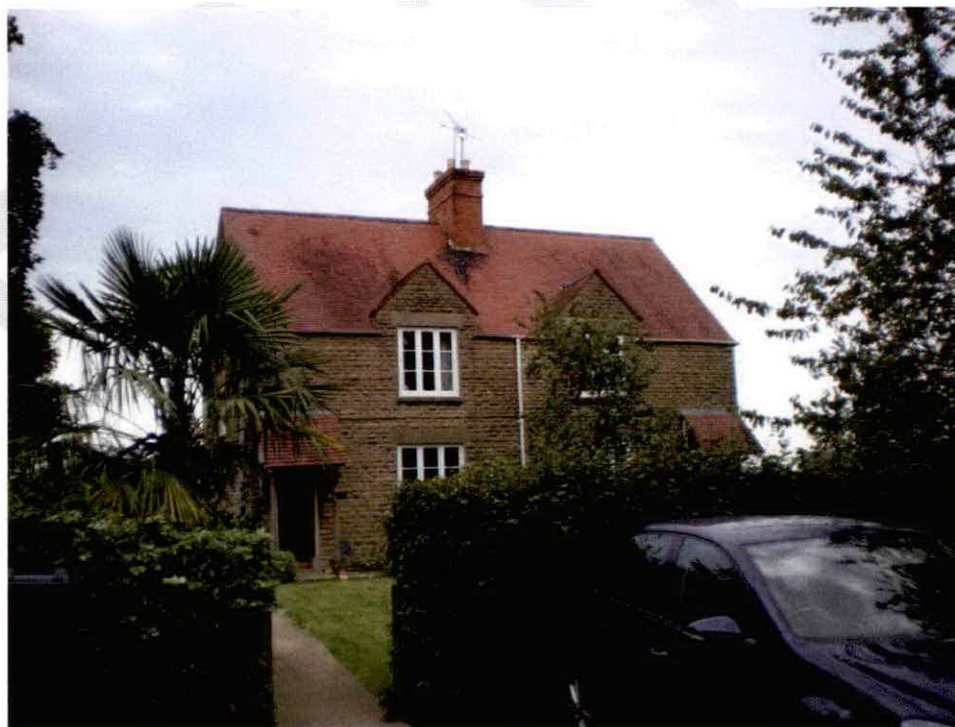
Figure 8: *A pair of unlisted late nineteenth century cottages to the north of the Church.*

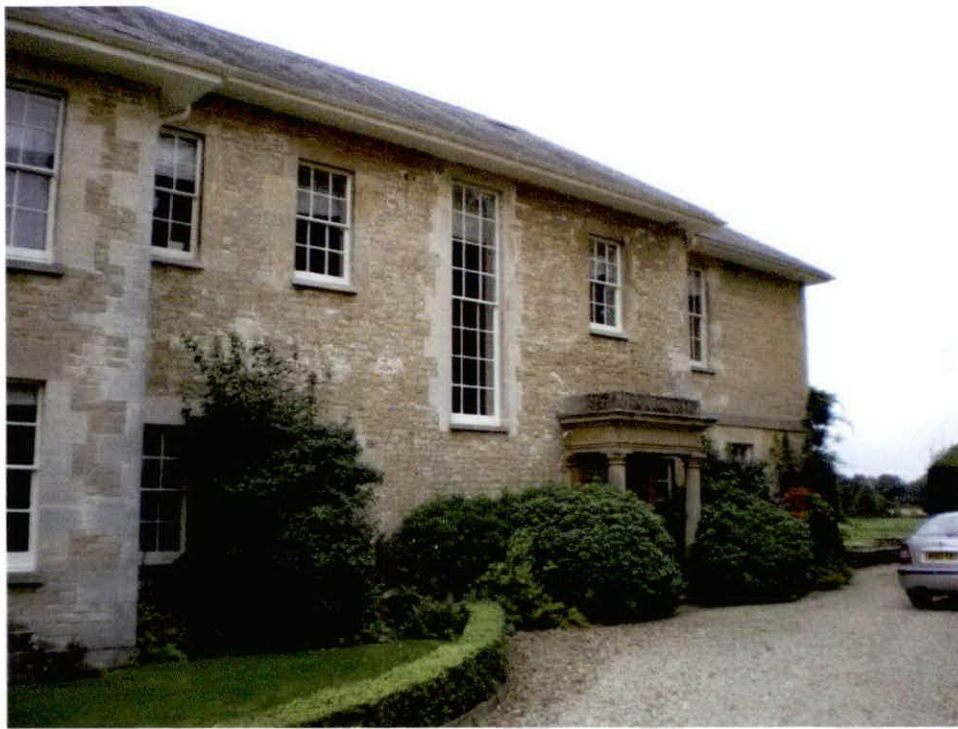
Figure 9: *Somerford Keynes House (Grade II Listed) dates to 1804 and is a large house built in the classical style, with overhanging hipped slate roof, sash windows and a Doric porch. The house is set within attractive grounds, open to the former parkland to its west.*

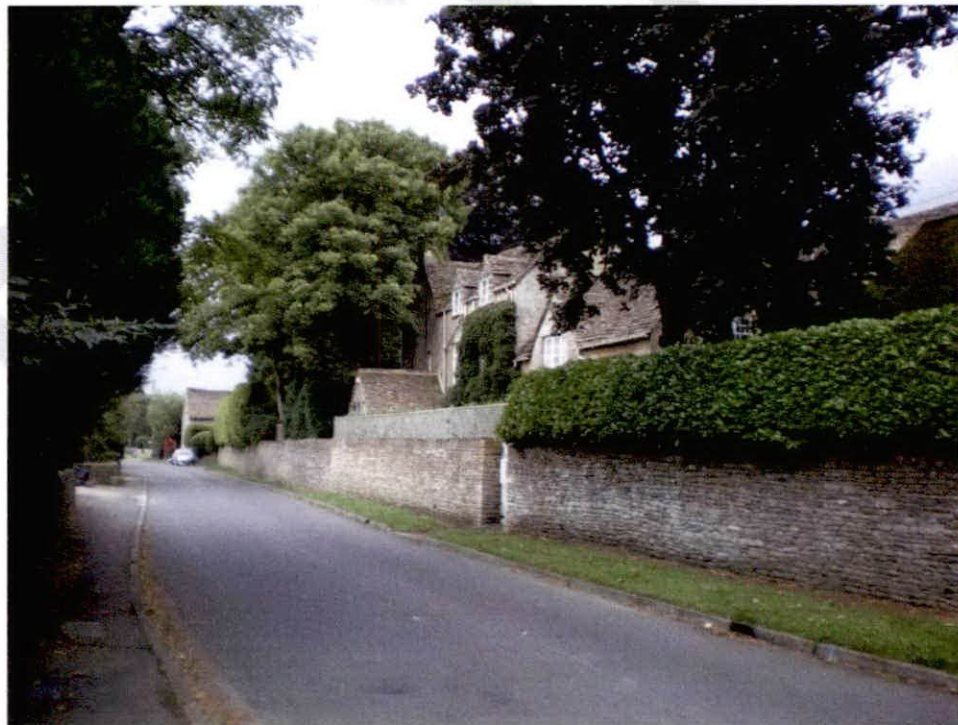
Figure 10: *Croft House (Grade II Listed) is a larger and higher status historic house within the village, with a politer architectural character. It dates to the early eighteenth century, with nineteenth and twentieth century alterations. It is set within large grounds, and views of the building are fairly restricted from the street due to a higher enclosing wall and trees.*

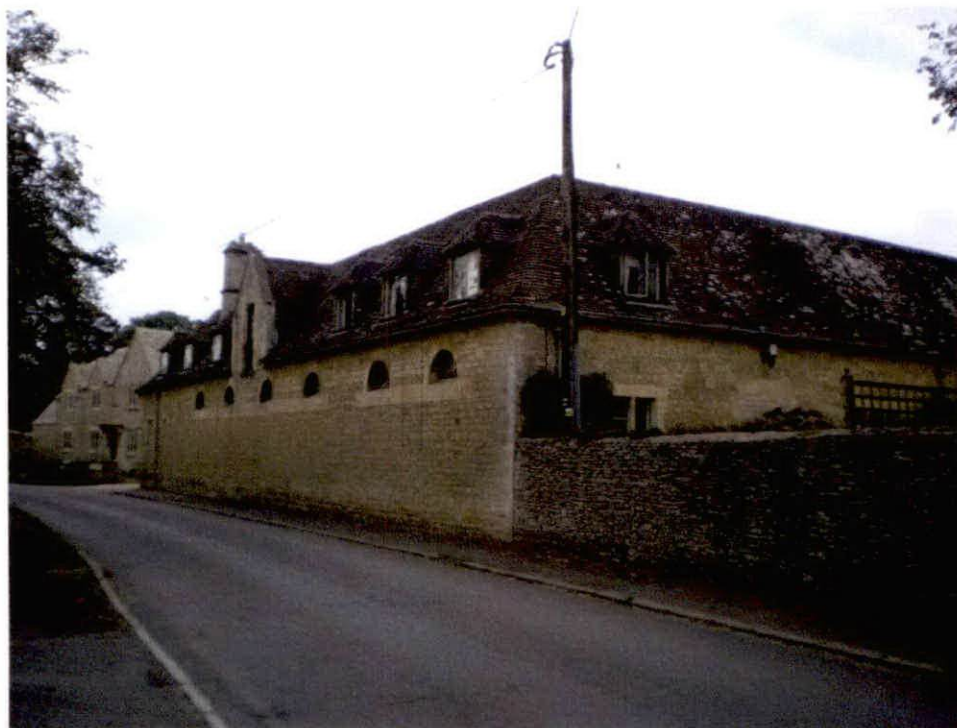
Figure 11: *The large stable block (Grade II Listed) adjacent to the Dower House, built in about 1920, has a plain clay tiled roof, with hipped dormers, and high level half-round windows set within stone surrounds.*

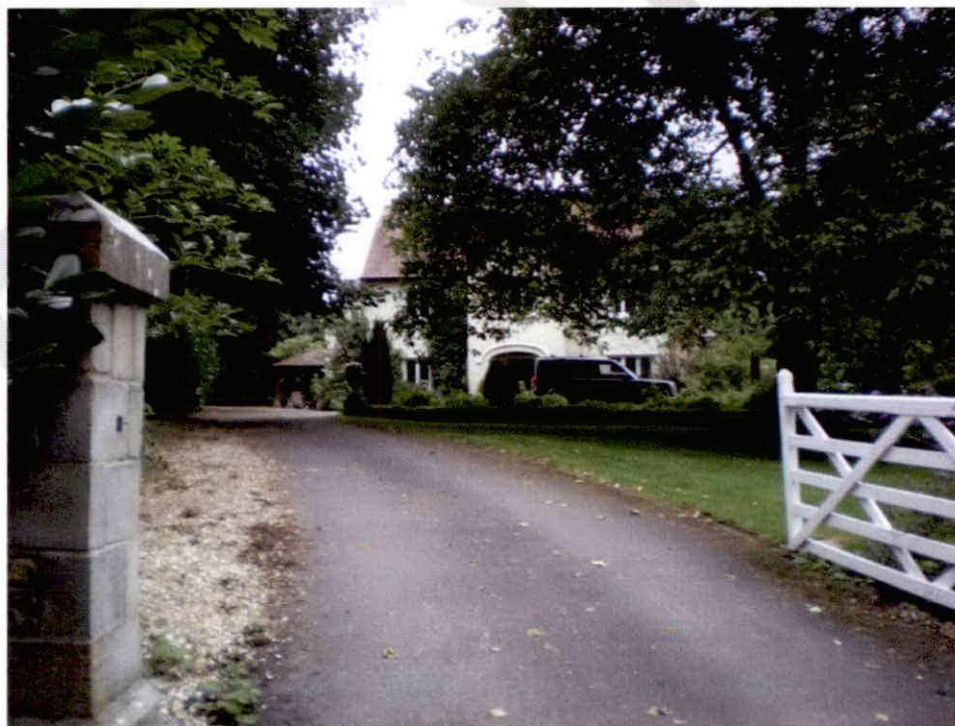
Figure 12: *The Old Vicarage dates to the 1920s, and was designed by the notable local architect V A Lawson. It, unusually for the village, is roughcast rendered.*

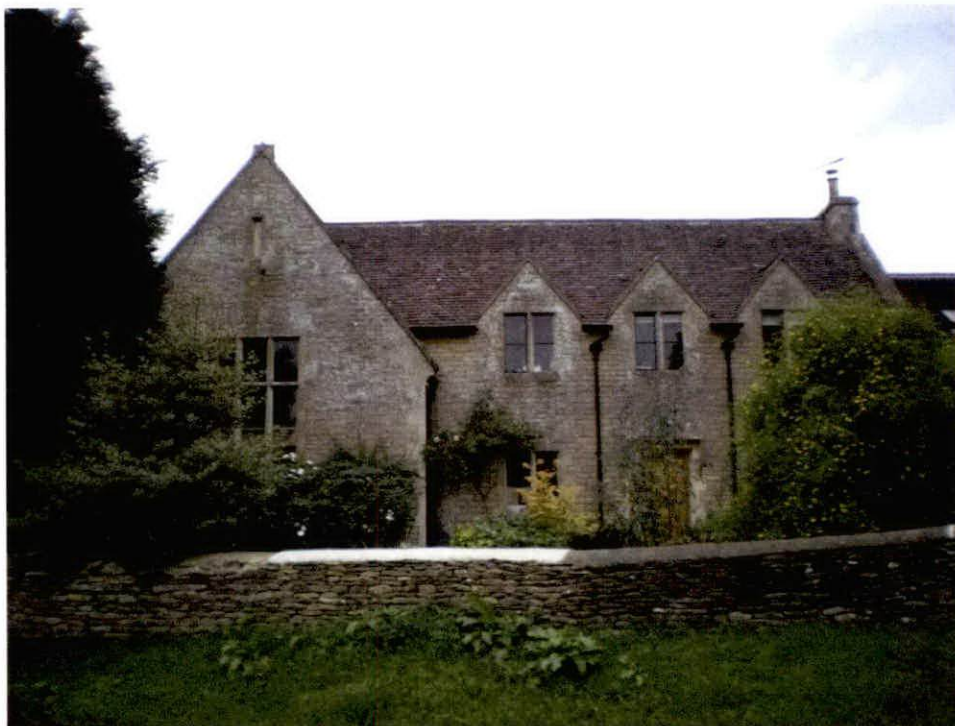
Figure 13: *The Old School House at the northern end of the village, dating to the nineteenth century.*

2.3.3 Most of the other historic buildings in the village are built in the Cotswold vernacular style. These include a public house, an old school house, the old post office, and numerous historic cottages. Typical characteristics of these buildings are:

- One-and-a-half to two-and-a-half storeys in height
- Simple in form, with narrow steep gables, and end of ridge chimneys
- Eaves and verges are plainly detailed in the local style
- Small casement windows and dormers

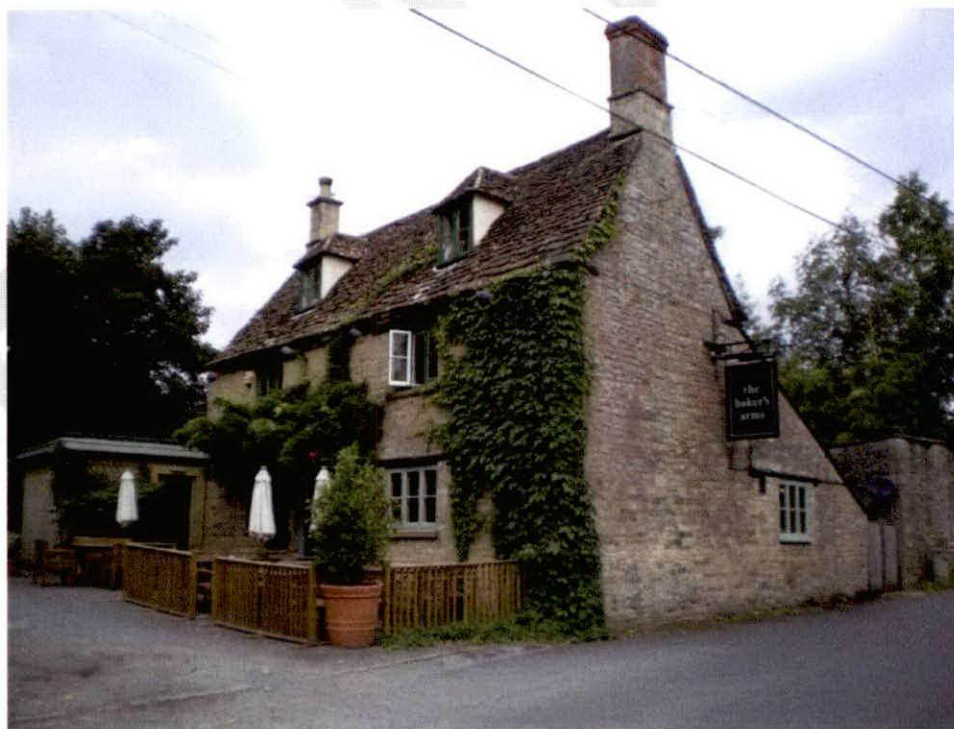
Figure 14: *The Bakers Arms pub (Grade II Listed) dates to the eighteenth century.*

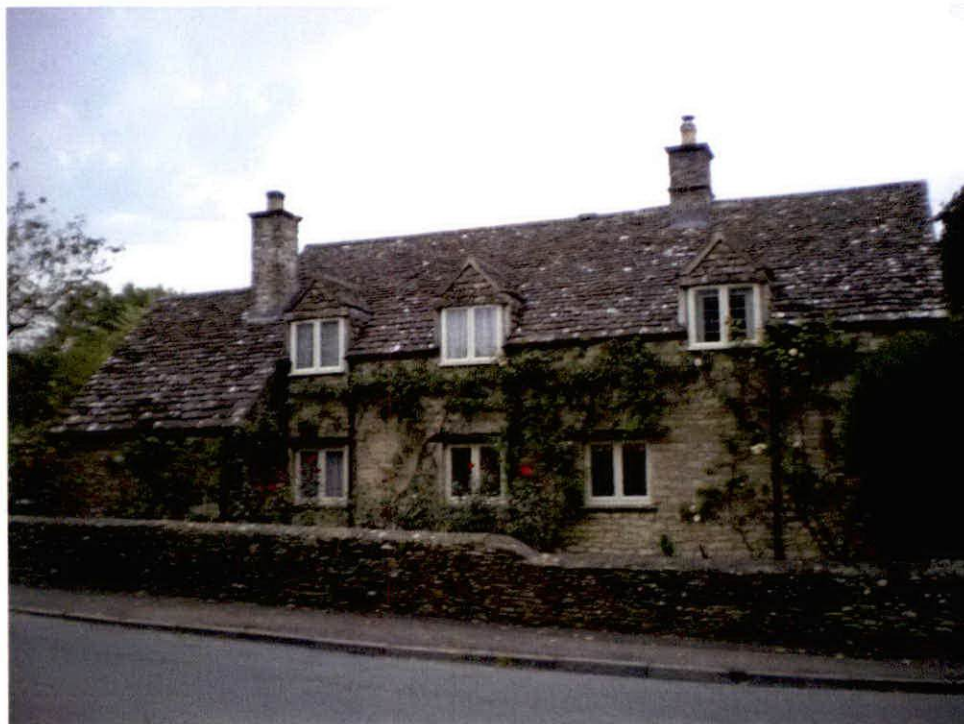
Figure 15: A Grade II Listed cottage, dating to the late seventeenth century.

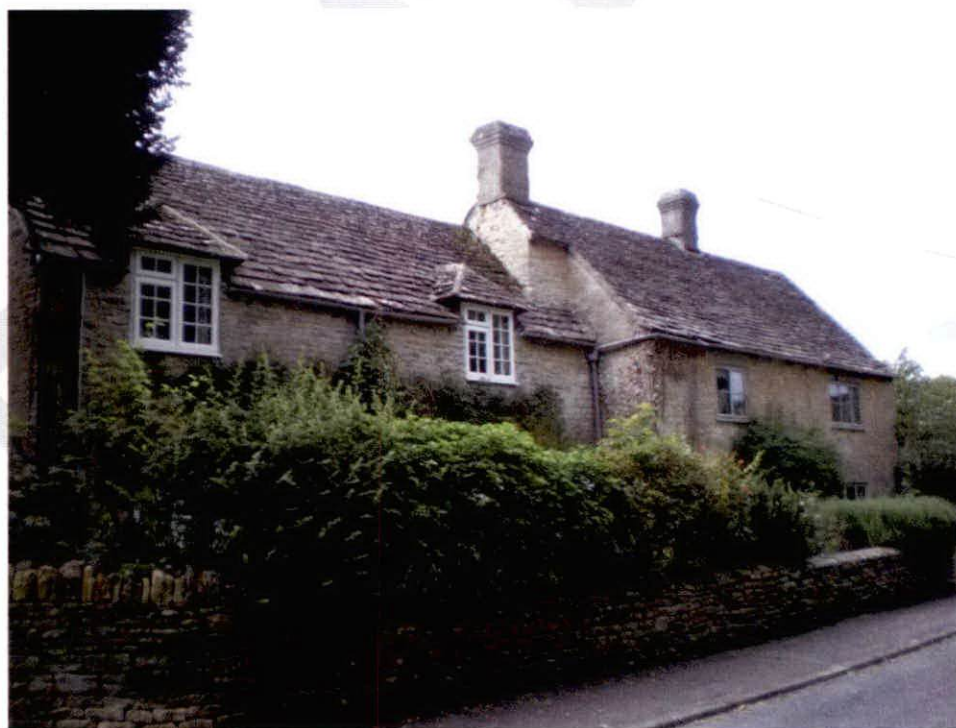
Figure 16: An unlisted cottage, with an attractive stone tile roof.

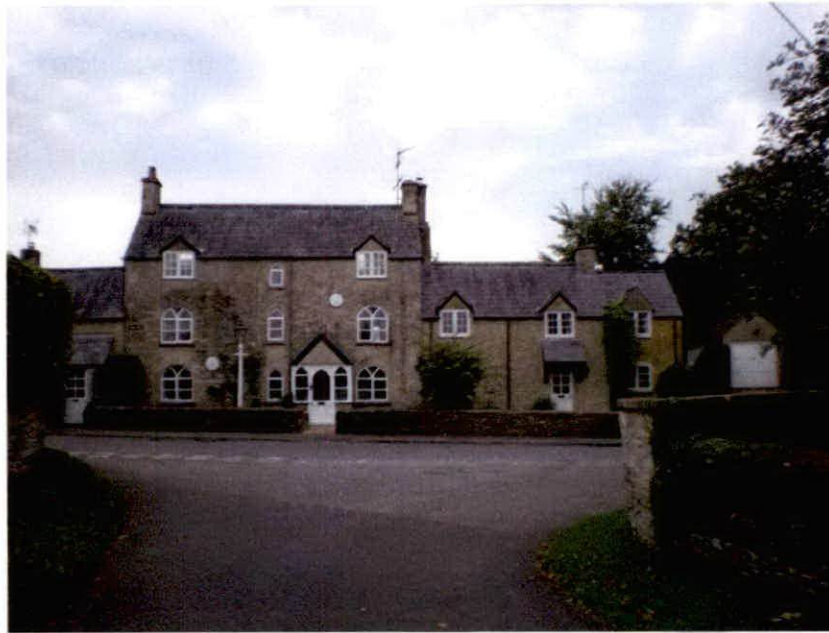
Figure 17: An unlisted cottage, with a blue slate roof, and distinctive arch-headed windows.
